AMATEUR SERVICE AGENCY BULLETIN NO. 1010

DATE: November 16, 1962
Page 1 of 2

EQUIPMENT TYPE: Power Supply 516F-2

SUBJECT: A. Bias Diode Change and Capacitor Change
B. Bias Voltage Range Increase
C. Check Wiring of Fuse F1

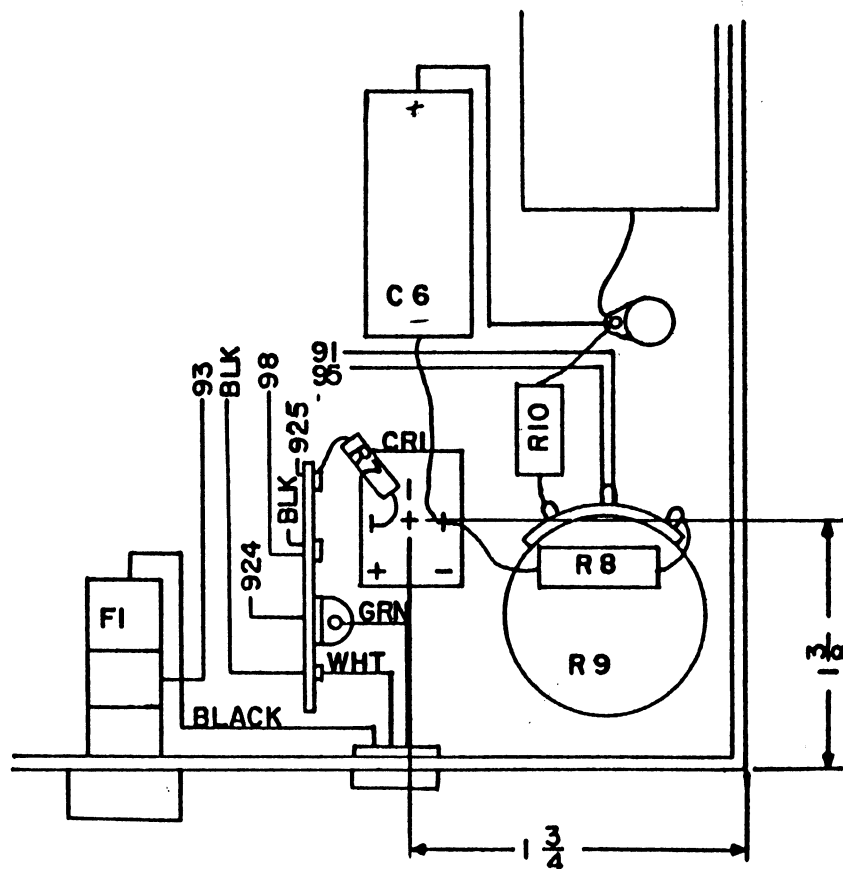
A high voltage transient in the bias line of some 516F-2's has been destroying the silicon diode (used in some models) which causes the filter capacitor to explode. If a failure occurs, the following modification is recommended (see sketch).

In some power supplies, the wires to the fuse holder XF1 were transposed. This makes the rim of the fuse hot with respect to ground. Check to see if the wires connected to fuse holder are in the same locations as shown in the sketch of Part A.

NOTE: In some cases a hole may have to be drilled in the chassis to facilitate mounting of the selenium diode.

In some cases the bias range of the 516F-2 may not be sufficient to give the desired idle current in a 32S or KWM-2. The following modification is then recommended. Make the changes of Part A with the following modification:

<u>CHANGE</u>	<u>TO</u>	<u>PART NUMBER</u>
R8, 4700 ohms, 2w	R8, 3300 ohms, 2w	745-5673-00
R9, 2500 ohms, 2w pot	R9, 5000 ohms, 2w pot	376-2376-00
