AMATEUR SERVICE AGENCY BULLETIN NO. 1012

DATE: 10-10-63

EQUIPMENT TYPE: 30S-1

SUBJECT: INTERMITTENT DROPOUT OF PLATE OVERLOAD RELAY

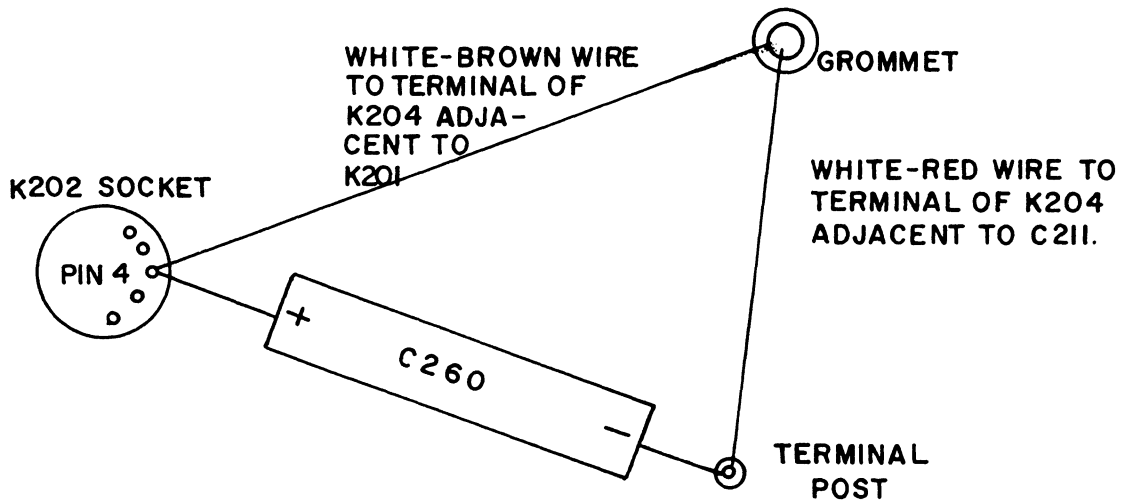
Some linear amplifier owners have experienced trouble with the plate overload relay, K204, occasionally dropping out during SSB operation. Sharp, fast rising voice characteristics that are passed before the exciter alc can respond, cause peak instantaneous plate currents in excess of one ampere in the amplifier tube, 4CX1000A. These peaks do not harm the tube but do occasionally cause the plate overload relay to energize which cuts off the plate high voltage.

If this phenomenon is encountered, we suggest installing a capacitor, 2000 uf, 6 volt electrolytic, across the coil of relay K204. This capacitor may be installed on the under side of the relay shelf and mounted between an unused terminal of socket for relay K202 and an insulated terminal post. The added wires are approximately 10 inches long.

The addition of this capacitor makes the overload circuit a very low impedance to audio frequency changes in plate current while still providing the desired overload protection for the PA tube. The change has been made in current production of 30S-1's.

1. Remove and turn relay shelf so as to gain access to lower side of shelf.
2. Remove and replace mounting nut for relay, K204, with terminal post, 306-0978-00.
3. Install capacitor and add wires per diagram.
