COLLINS RADIO COMPANY

SERVICE BULLETIN NO. 1

EQUIPMENT SERIES: 32S-3

SUBJECT: IMPROVE VOX CIRCUIT TO ELIMINATE INTERMITTENT DROPOUT, AND IMPROVE OPERATION OF FIRST AUDIO AMPLIFIER

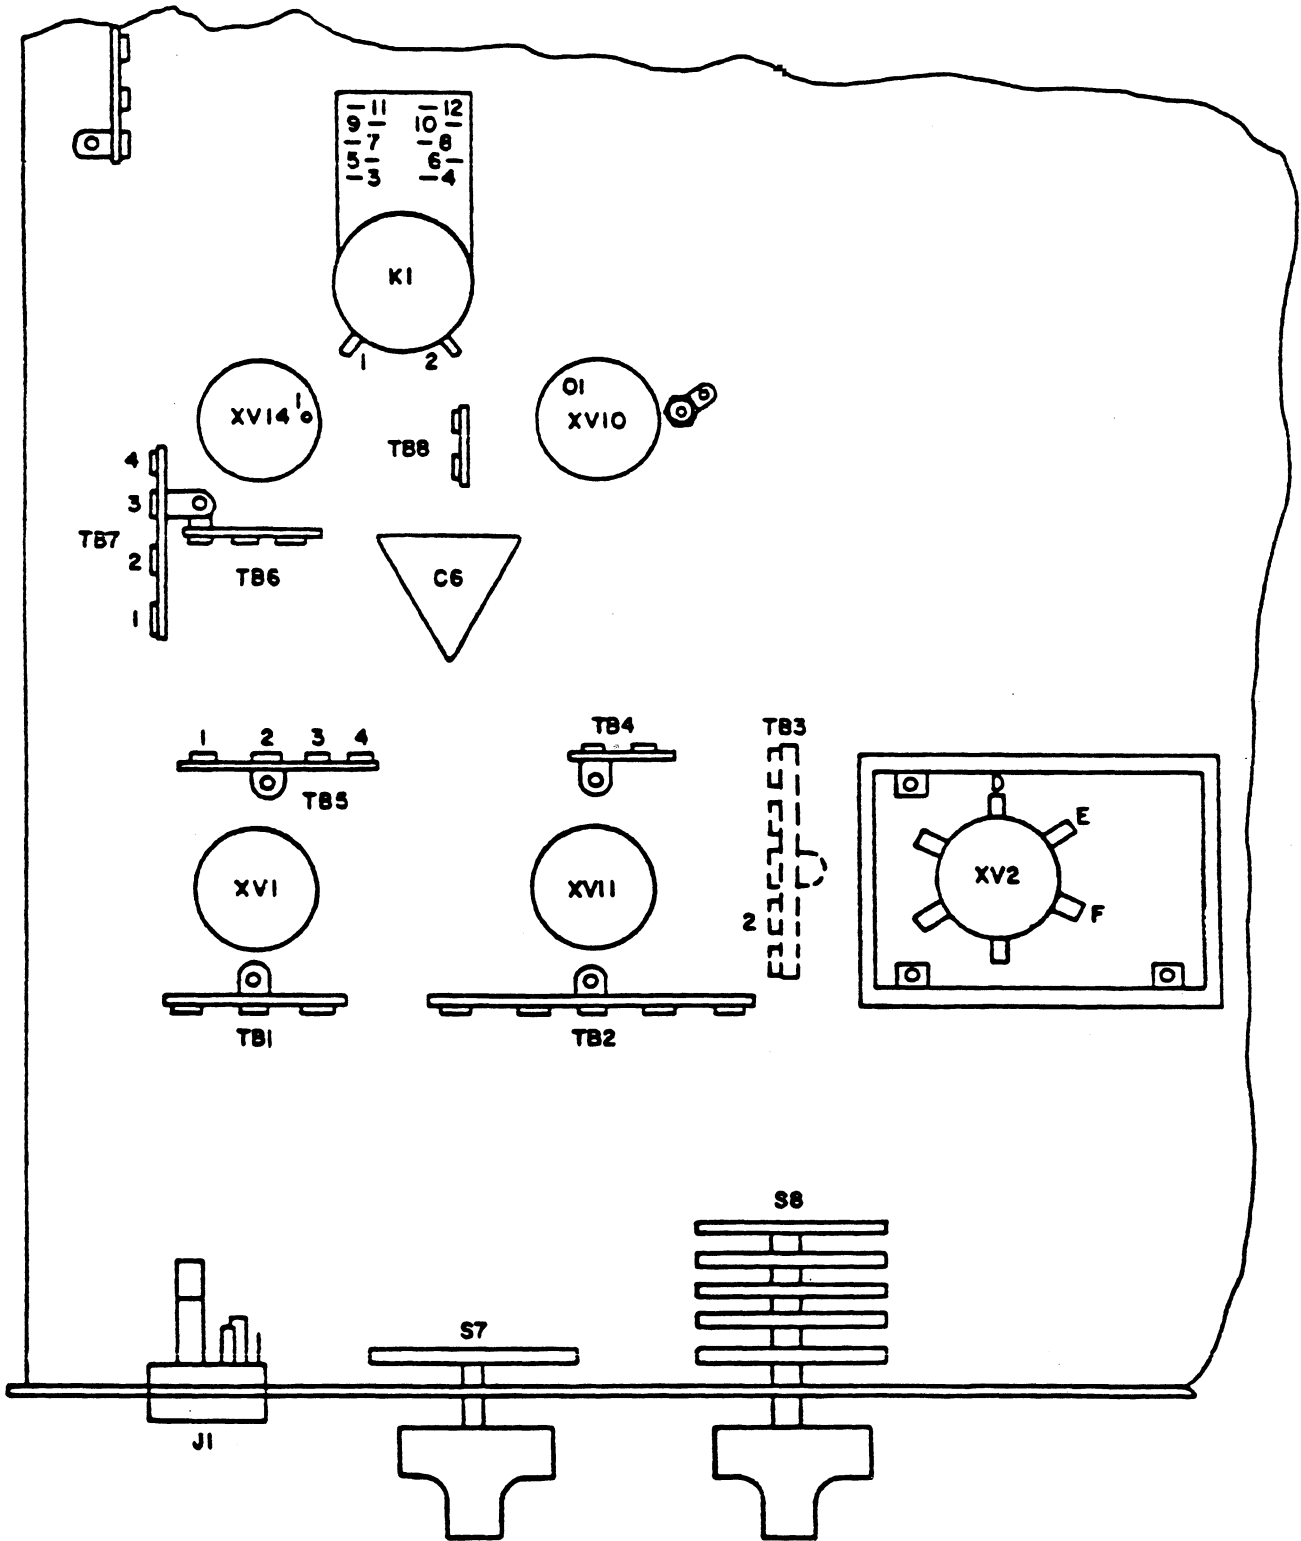
The second purpose of this modification is to improve the overall performance of the first audio amplifier. It has been established that choke L1 in the grid circuit of tube V1 is self-resonant at random frequencies, which sometimes results in various unrelated malfunctions. These malfunctions usually occur when accessories (phone patch, linear amplifier, etc.) are employed. Choke L1 is replaced with a resistor, and the circuit for V1 is altered to perform this modification.

32S-3 Chassis, Partial View Showing Location of Components Affected by This Modification

2. Substitute new 47K resistor R138 (745-1422-000) for choke L1. The choke is connected between tube socket XV1, pin 9, and terminal strip TB1.
3. Substitute new 100K resistor R101 (745-1436-000) for 1-megohm resistor R101. This resistor is located on terminal strip TB1.

4. Connect new 0.1-uf capacitor C188 (913-3152-000) between XV1, pin 8, and the ground terminal of terminal strip TB5.
5. Substitute new 0.02-uf capacitor C119 (913-2142-000) for 0.1-uf capacitor C119. Capacitor C119 is located between tube socket XV10, pin 5, and terminal 11 of relay K1.

6. Connect two new 0.1-uf capacitors C186 and C190 (both 913-3152-000) in parallel between XV10 pins 5 and 7.
7. Connect new 20-uf capacitor C184 (183-1165-000) between XV14, pin 8 (positive lead), and TB7, terminal 3 (negative lead).

8. Connect new 20-uf capacitor C185 (183-1165-000) between XV14, pin 3 (positive lead), and TB5, terminal 2 (negative lead).
9. Substitute a new 220K resistor (745-1450-000) for 680K resistor R73. Resistor R73 is connected between XV2, pin 9, and TB3, terminal 2. Transmitters that have a shield around XV2 do not have a terminal board TB3, and R73 is connected

between XV2, pin 9, and XV2, terminal F. To remove the shield, disconnect the choke L2 lead from XV2, terminal E, and the capacitor C92 lead from XV2, terminal D. Remove the three screws that secure the shield in place. These screws are removed from the top of the chassis. After R73 has been replaced, reconnect the component leads to the original terminals, and replace the shield.
