516F-2 AC POWER SUPPLY (522-1170-000)

SERVICE INFORMATION LETTER 1-76

PREVENT FUSE BLOWING CAUSED BY ARCING IN THE VACUUM TUBE RECTIFIERS

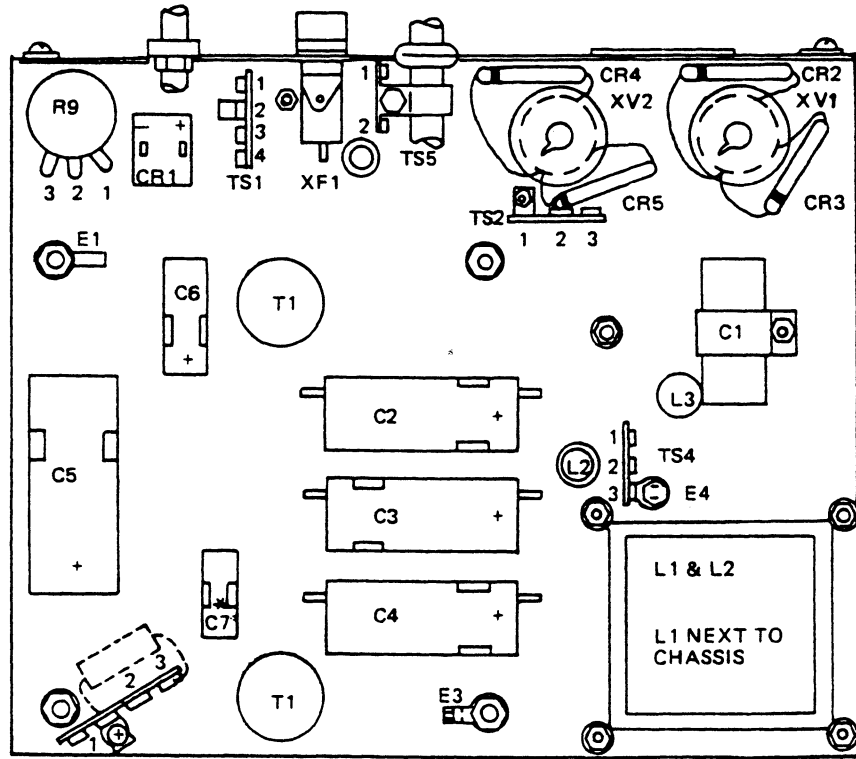
CR2, 3, 4, 5 Mounting Location
Figure 1

A few problems have been reported from the field concerning blown fuses in the 516F-2 power supply. Investigation has shown that the cause of the problem is arcing in rectifier tubes V1 (5R4GYA) and V2 (5U4GB). However, most of these tubes are performing satisfactorily so this service information letter is intended only for those power supplies that have a fuse blowing problem.

Vacuum tubes V1 and V2 should be removed and Semtech SCH-5000 solid state diodes (CPN 353-0425-010) should be installed as follows.

<u>DIODE</u>	<u>FROM</u>	<u>TO</u>
CR2	XV1-8 (cathode)	XV1-4
CR3	XV1-8 (cathode)	XV1-6
CR4	XV2-8 (cathode)	XV2-4
CR5	XV2-8 (cathode)	XV2-6

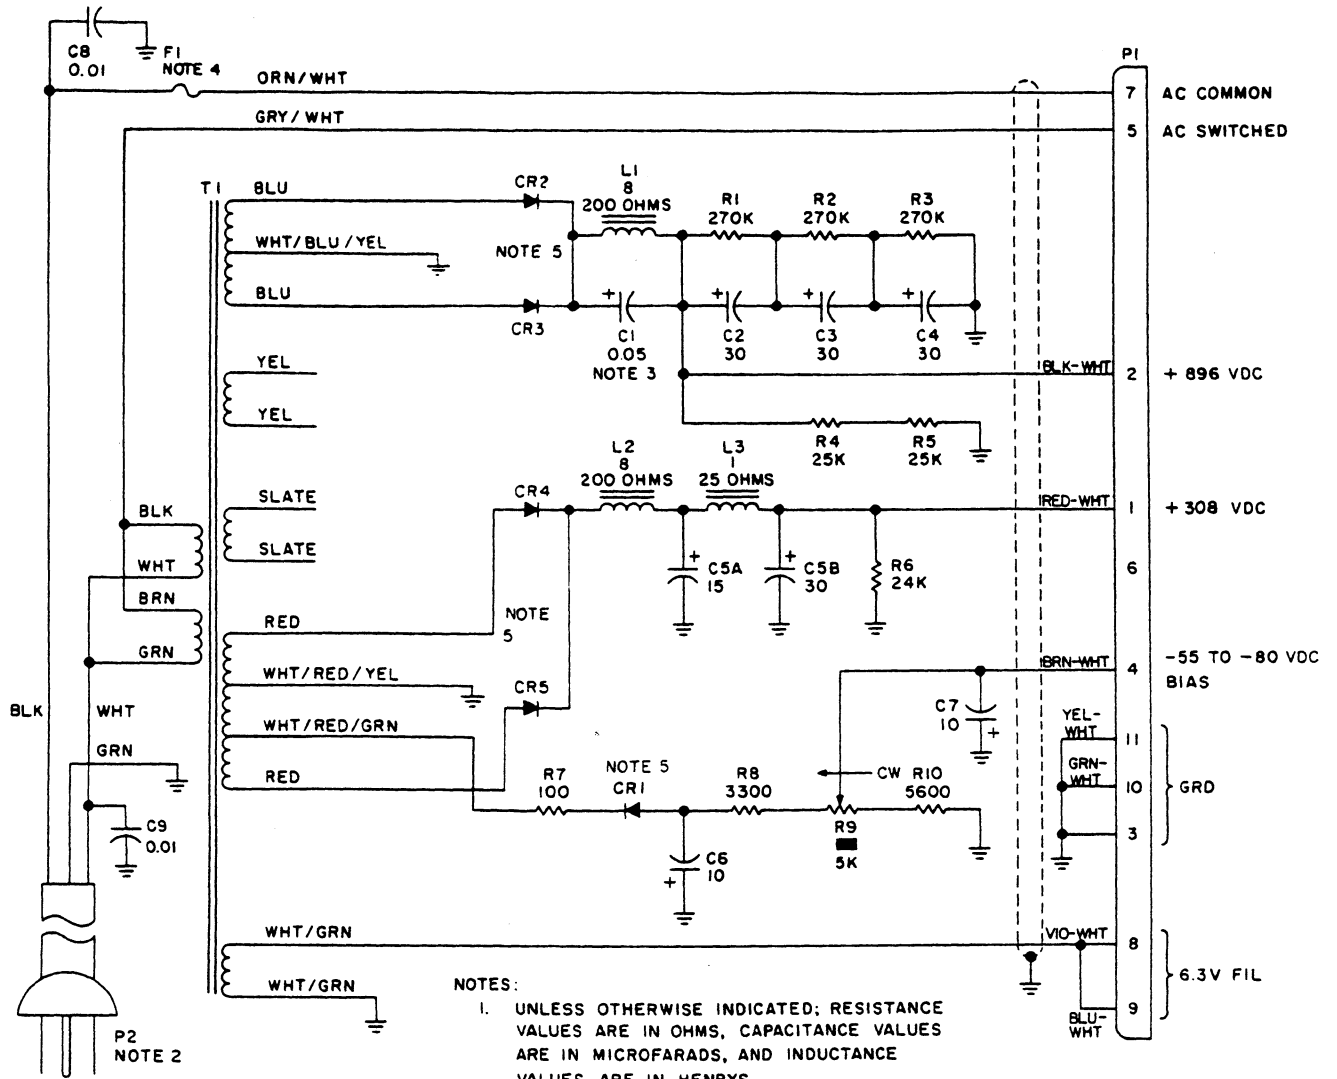
516F-2 AC Power Supply, Schematic Diagram
Figure 2

This change will increase the output voltage to the KWM-2/2A and 32S-() transmitters by approximately 12 percent. The respective bias must be adjusted using the transmitter instruction books as a guide. It is recommended that the transmitter final amplifiers be kept at resonance at all times and that the swr always be less than 2:1.
