AMATEUR SERVICE AGENCY BULLETIN 1015

DATE: July 30, 1965

EQUIPMENT TYPE: 30S-1 LINEAR AMPLIFIER

SUBJECT: 1. CABINET VIBRATION ELIMINATION  
2. EXCESSIVE ALC CONTROL

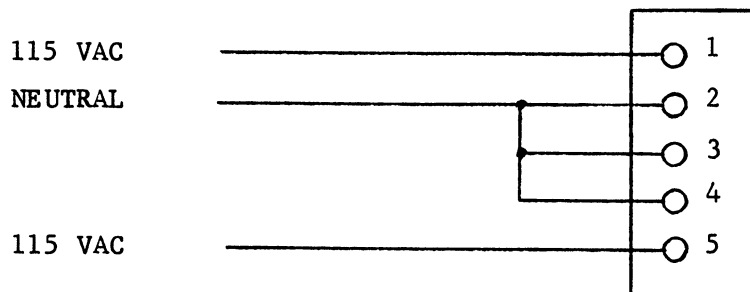
1. A mechanical vibration of the sides of the amplifier cabinet when operated from 220V has been found to be a noisy problem in some units. The cause has been found to be the external field of the plate transformer exciting the side of the cabinet.

terminal board TB201 connections for 220 V operation should be as follows:

To remedy this situation, tie the common terminals of the series connected transformer primaries to the power line neutral.

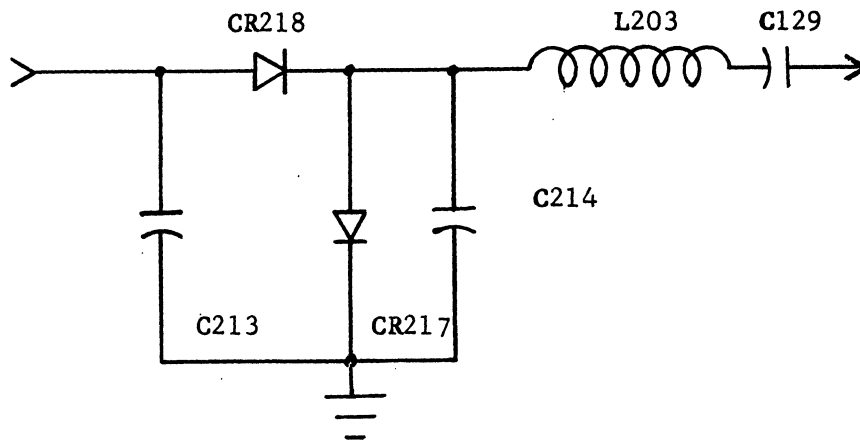
Diode Replacement For V203

2. Some trouble has been experienced in the past with too much ALC override from the 30S-1 to the exciter. This is caused by excessive standoff voltage in the 12AL5 ALC rectifier, V203. To reduce this tendency, V203 was selected during test for minimum optimum operation. The problem may be completely eliminated if the 12AL5 dual diode is replaced with two 1N457 silicon diodes (353-0204-000).
