EQUIPMENT TYPE KWM-1

BULLETIN NO. 1

9-12-58

SUBJECT A: Improvement in Calibrator Operation**B: Spurious Outputs of KWM-1****C: Transient in Speaker when Switching from Receiver to Transmit****D: Hum in Speaker when AF Gain Control is Advanced in CW Operation****E: "Tweets" in Audio Output Caused by DC Power Supply**

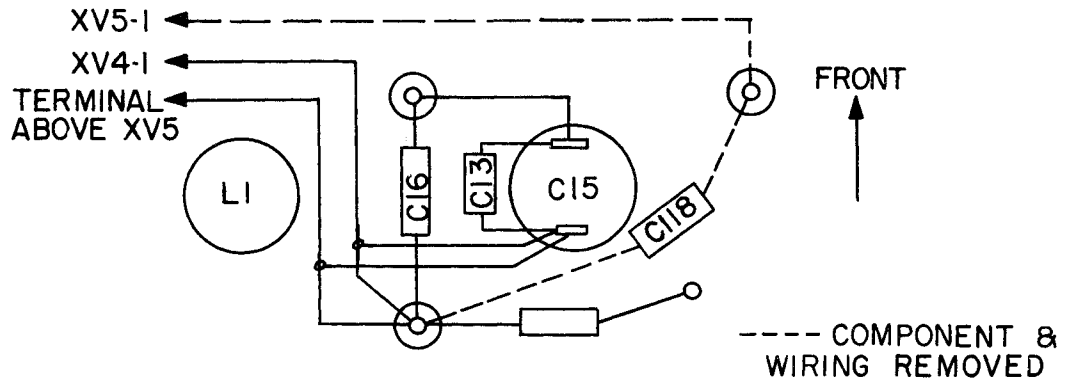
Figure 1. Wiring Location of L1 Shield Can

It has been noted that multiple beats are present in Calibrate position of the Emission Switch. The following modification will increase the strength of the correct calibration signal. Units using a type 6AU6 tube for V1 require this modification.

lead are connected to insulated terminal mounted on trimmer capacitor. Discard coax and capacitor. See figure 1.

7. Install a five inch length of coax cable (425 0926 00) from terminal directly over XV5 pin 9 (installed in step 5) to insulated terminal to which C16 and coax cable to XV4 pin 1 is connected. See figure 1. Ground coax shield to C15 as shown in figure 1. Ground shield at C15 end only.

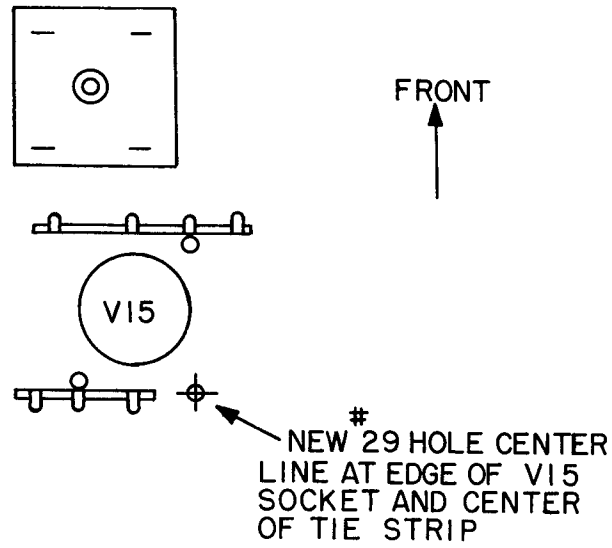
Figure 4. Location of Number 29 Hole for Installation of Insulated Terminal

In some KWM-1 transceivers a popping noise is evident when changing from receive to transmit. This noise may be greatly reduced by the following modification. Serial number effectivity 861.

1. Remove the 330K 1/2 watt resistor, R124, connected to terminal on terminal strip behind XV12. (See Figure 6). R124 should be removed by cutting from the strip and discarded.
2. Carefully drill a number 29 hole next to tie strip at rear of XV15 as shown in figure 4. Care should be taken not to damage cable harness.
3. Mount insulated terminal (306 0233 00) in hole drilled in step 2 using 4-40 x 3/16 screw (343 0284 00).
4. Connect a new 330K resistor, R124, (745 1457 00) from center terminal of terminal strip behind XV12 to insulated terminal installed in step 3.
5. Connect 330K resistor, R156, (745 1457 00) from insulated terminal installed in step 3 to

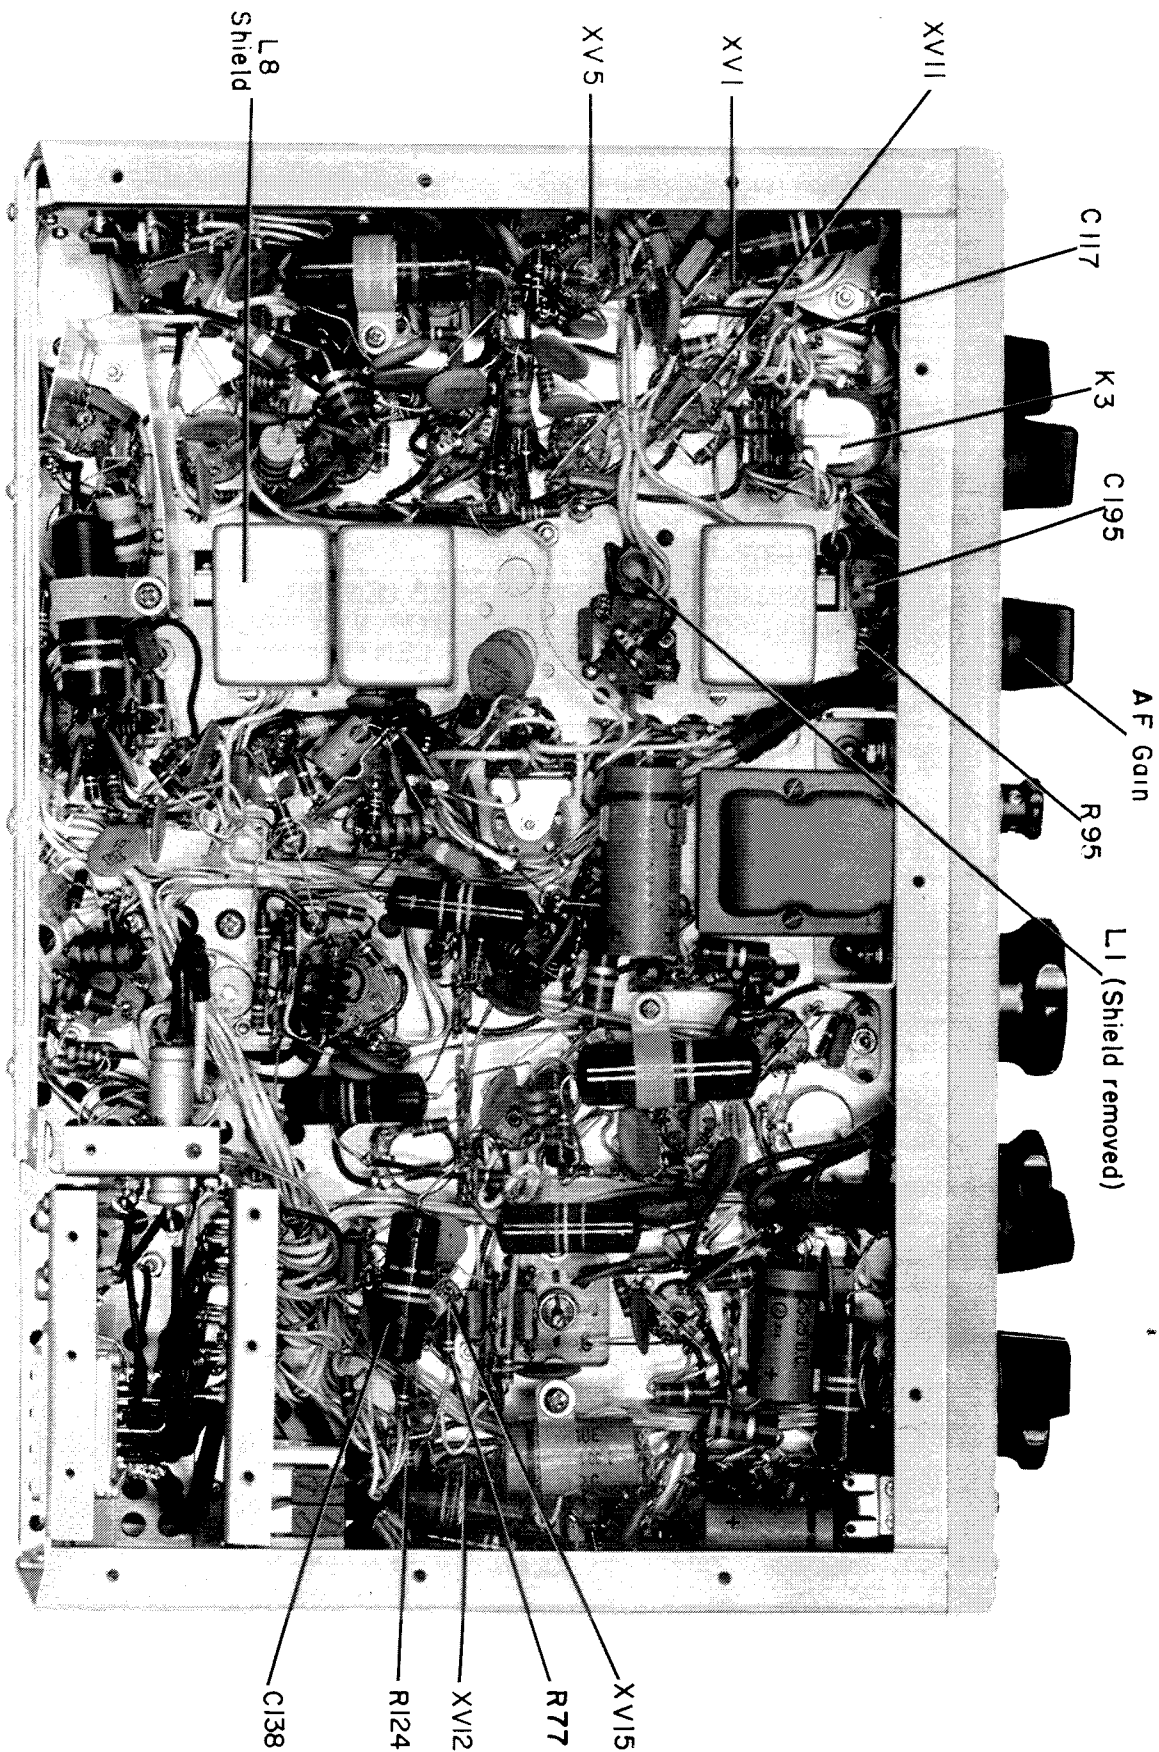
Figure 6. Location of Components, Bottom View

In earlier models of the KWM-1, some hum could be heard if the AF Gain control was run high when in CW operation. This is actually a low frequency oscillation in the sidetone circuit and may be eliminated by the following modification. Units that have this modification installed will have a four terminal tie strip mounted directly behind the RF and AF gain controls with a 470 K 1/2 watt resistor connected in series with a 220 uuf capacitor mounted on the strip. Figure 6 shows the modified circuit.

3. Remove L1 coil can. (L1 can is located beside XV4 and is second can nearest front of the unit). See figure 6.

1. Remove the L8 shield can. See figure 6.
2. Install five ground clips (220 1323 00) around edge of the can and replace in original location. Make sure that can mounting nuts are tight.

6. Connect .1 uf capacitor, C204, (931 0299 00) from insulated terminal installed in step 3 to same ground as C138. See figure 6.
7. Check XV15 pin 2 for the presence of a 2.2 mh rf choke connected across the 100K resistor connected to this pin.
8. If the choke is not present, connect a 2.2 mf choke (240 0084 00) across the 100K resistor, R77, connected to pin 2 of XV15.
9. Refer to figure 5 for schematic of completed modification.
