# SERVICE BULLETIN

HF-380 TRANSCEIVER (622-3580-001)  
KWM-380 TRANSCEIVER (622-5093-001)  
SYNTHESIZER VARIABLE REFERENCE FREQUENCY LOOP A5A2 (638-6920-001)

SERVICE BULLETIN NO 16  
(SUPERSEDES SERVICE BULLETIN NO 3)

ELIMINATE FREQUENCY WARBLE AND REDUCE 500-Hz SIDEBANDS  
ON INJECTION FROM SYNTHESIZER

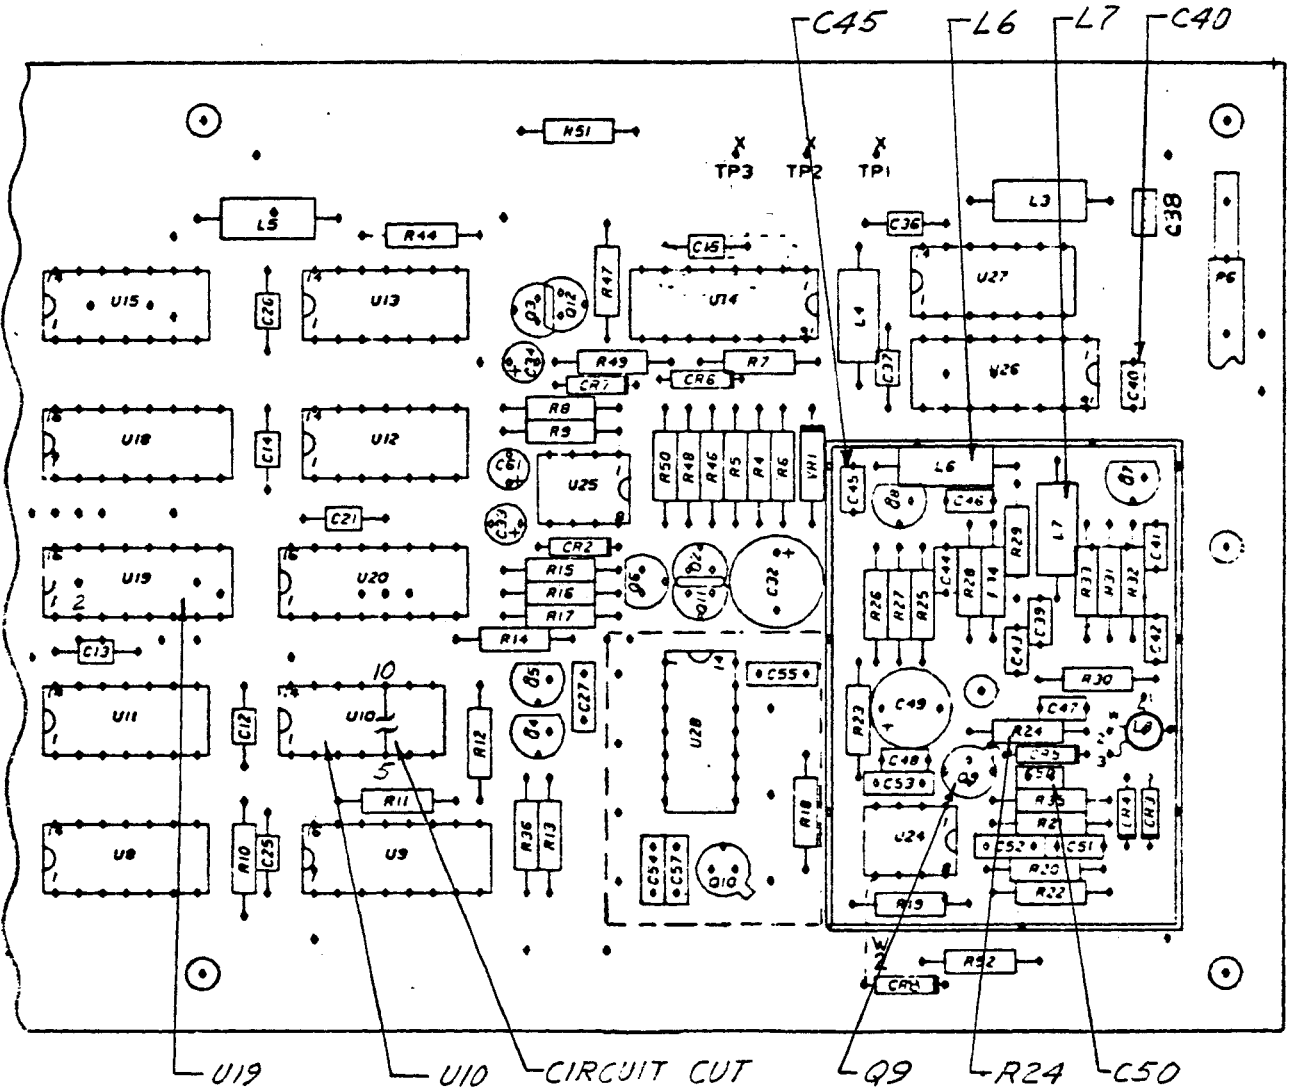
P/O Synthesizer Variable Reference Frequency Loop A5A2  
Figure 1

A frequency warble may occur at certain frequencies in some radios. The warble will usually occur at the top end of each 1-MHz band. The problem has been traced to two integrated circuits on synthesizer variable frequency loop A5A2. When U14 and U26 are at the low end of their specified parameters, a low rf input may cause them to miscount. Steps F through L of the modification procedure will correct this problem.

- F. Remove 4-pF capacitor C40 and replace it with a 12-pF capacitor (912-4141-120).
- G. Remove 4-pF capacitor C45 and replace it with a 12-pF capacitor (912-4141-120)
- H. Remove transistor Q9 (2N5486) and replace it with a 2N5397 transistor (352-0998-010).
- I. Remove 0.15- $\mu$ H coil L6 and replace it with a 0.10- $\mu$ H coil (240-2723-140).
- J. Remove 0.15- $\mu$ H coil L7 and replace it with a 0.10- $\mu$ H coil (240-2723-140).
- K. Remove 47-pF capacitor C50 and replace it with a 27-pF capacitor (913-1098-570).
- L. Remove 154- $\Omega$  resistor R24 and replace it with a 56- $\Omega$  resistor (745-0704-000).
- M. On the bottom of the card, cut the circuit trace which connects U10-5 to U10-10.
- N. Install a jumper wire (428-0282-050) from U19-2 to U10-5 on the bottom of the card.
- O. Mark SB 16 on the circuit card near the part number.

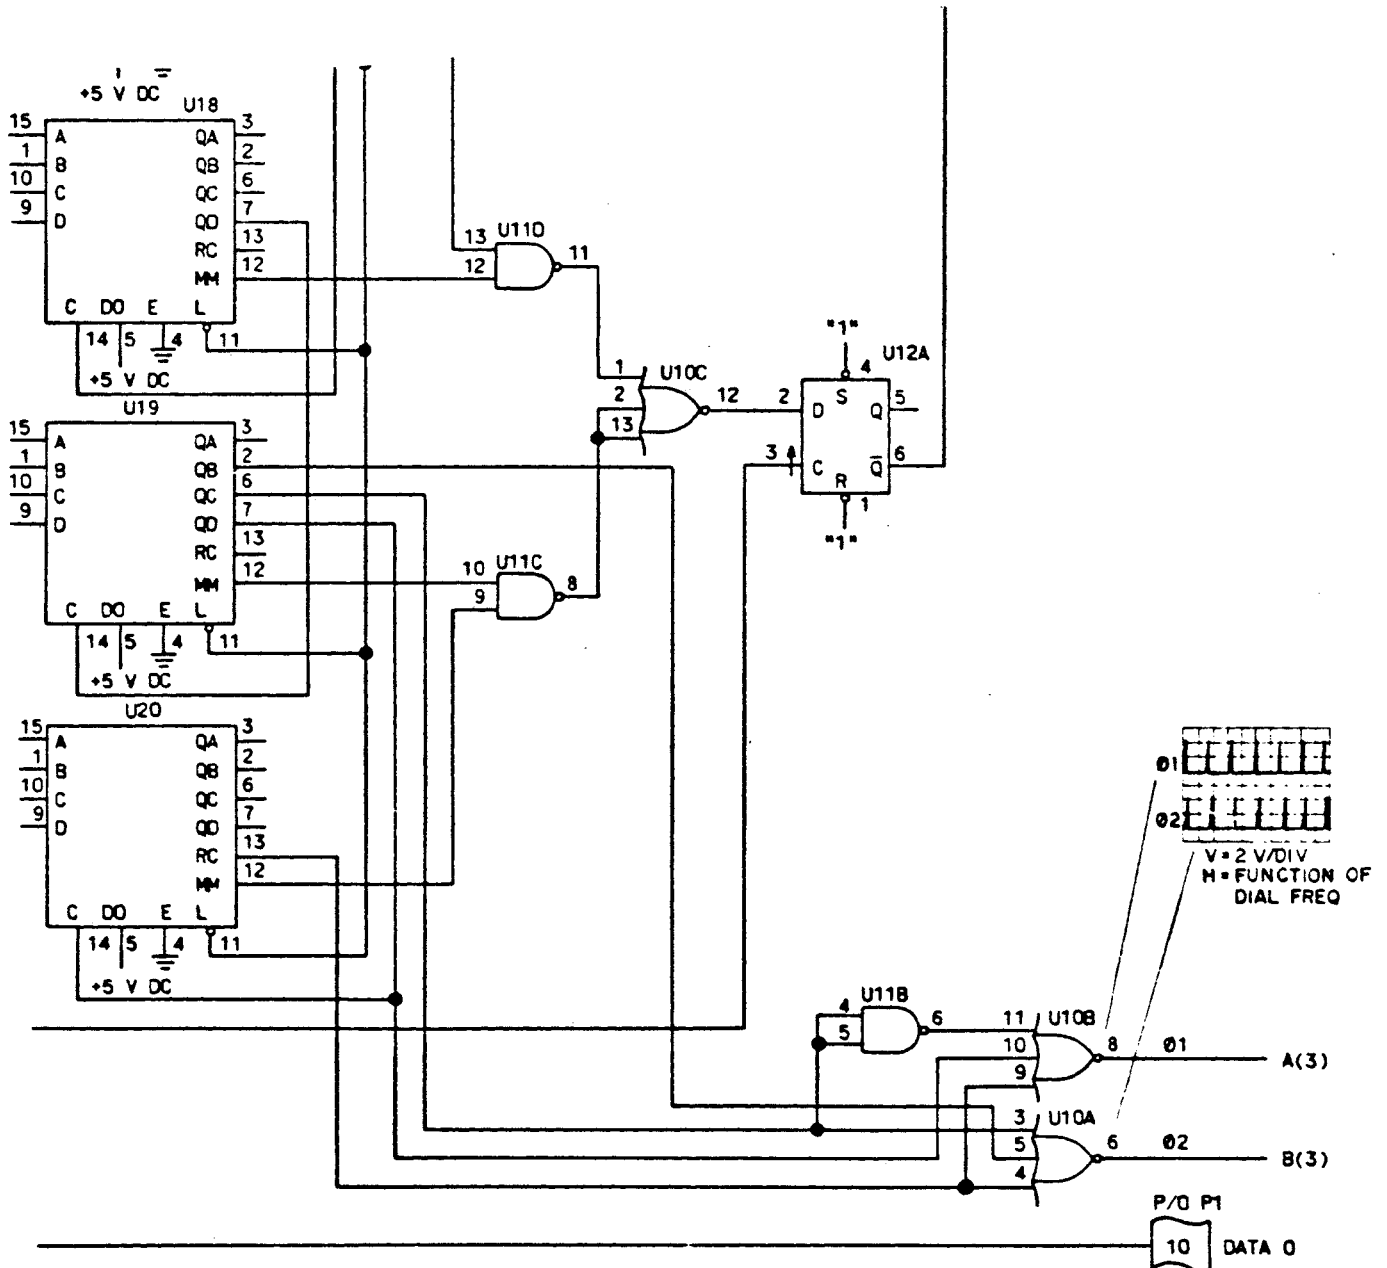
P/O Synthesizer Variable Reference Frequency Loop A5A2, Schematic Diagram  
Figure 2

The synthesizer 500-Hz sidebands can be observed as a false signal 500 Hz away from a strong cw carrier when tuning with a narrow cw crystal filter. This service bulletin (steps M and N of the modification procedure) reduces the 500-Hz sideband level on the synthesizer output (first receiver mixer local oscillator).
