SERVICE BULLETIN

KWM-2/2A TRANSCEIVERS (522-1611-000, 522-1792-000)

SERVICE BULLETIN NO 10

SUBJECT: Eliminate vhf parasitic oscillations in tone oscillator, V2B

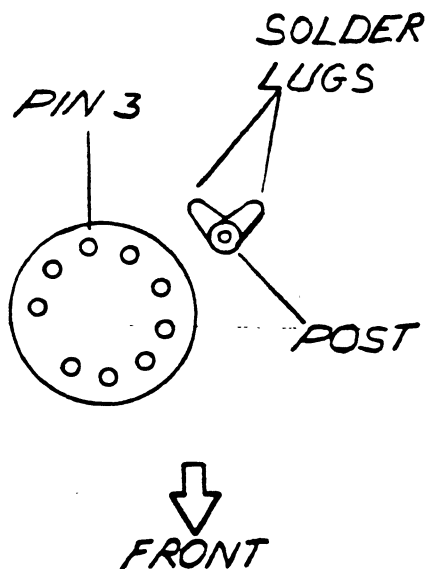
V2 Socket, Bottom View
Figure 1

Some units may have an audible 1000-Hz tone in CW mode with the key open. This is caused by vhf parasitic oscillations modulating the tone oscillator.

A 47-ohm resistor is added in series with the screen grid of tone oscillator V2B to act as a parasitic suppressor.

- c. Refer to figure 1 and perform the following:
1. Locate and disconnect the 0.1- μ F capacitor, C49, and the 100-k Ω resistor, R49, from pin V2-3 (leave other ends connected).
 2. Remove and discard hardware securing solder lugs (near V2) to chassis.
 3. Install new post (306-0977-000) on top of two solder lugs by V2, using new screw (343-0286-000).
 4. Connect one end of new 47-ohm resistor (745-1296-000), R215, to pin V2-3 and other end to new post.
 5. Connect R49 and C49 leads (disconnected in step c.1) to new post.
- d. Reassemble cabinet.
- e. Check transceiver for proper operation and verify that no audible tone exists in CW mode with the key open.
- f. Enter SB 10 on the information chart (280-3778-010); apply chart to convenient location on unit if one is not present.
