1 October 1971

KWM-2/KWM-2A TRANSCEIVERS SERVICE BULLETIN NO 3 (REISSUE)

EQUIPMENT: KWM-2 Transceiver (522-1611-000)
KWM-2A Transceiver (522-1792-000)

SUBJECT: Correlation Between Frequencies on Different Bands

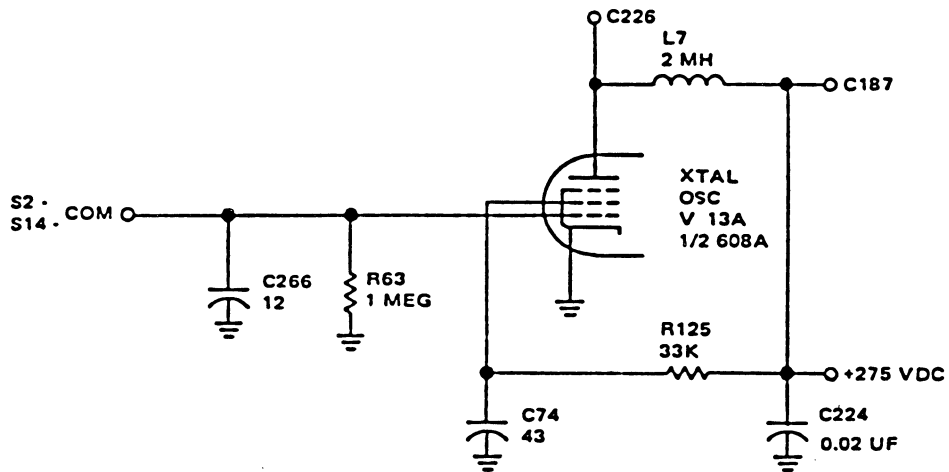
KWM-2 After Modification, Schematic Change

The correlation between frequencies on different bands of the KWM-2/2A is improved by this modification. This results in less need for pto zero hairline adjustment when switching between bands and also in overall improved equipment performance.

NOTE:
C266 NOT USED IN KWM-2A.

- c. Remove and discard 27-pF capacitor C266, if present, from XV13A pin 2 to the center shield of V13 (ground), and install at this location a 12.0-pF capacitor (912-2757-000), KWM-2 only.
- d. Remove and discard 47-k Ω resistor R125 from XV13A pin 2 to vector terminal board E100, and replace with 33-k Ω resistor (745-1415-000).
- e. Remove and discard 47-pF capacitor C74 from XV13A pin 3 to ground, and replace with 43.0-pF capacitor (912-2789-000).
- f. Inspect unit for damage incurred during modification, dress wires and cables, and remove debris.
- g. Reassemble unit by reversing step a.
- h. Check transceiver for proper operation.
- i. Mark information chart (280-3778-010) SB 3R. Apply chart to convenient location on unit if one is not present.
