KWM-380 TRANSCEIVER (622-5093-001, -101) HF-380 TRANSCEIVER (622-3580-001, -101) SYNTHESIZER VARIABLE REFERENCE FREQUENCY LOOP A5A2 (638-6920-001)

SERVICE BULLETIN NO 3

POTENTIAL FREQUENCY WARBLE

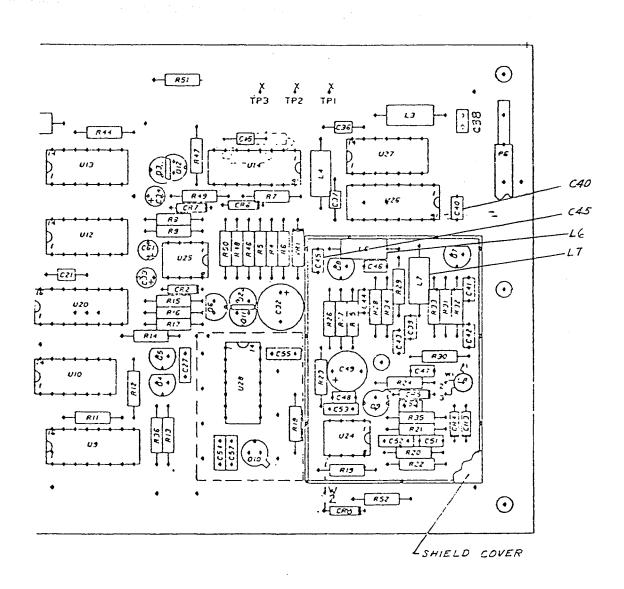
P/O Synthesizer Variable Reference Frequency Loop A5A2 Figure 1

A frequency warble may occur at certain frequencies in some radios. The warble will usually occur at the top end of each 1 MHz band. The problem has been traced to two integrated circuits on synthesizer variable reference frequency loop A5A2. When U14 and U26 are at the low end of their specified parameters, a low rf input may cause them to miscount.

NOTE: Refer to figure 1 while performing steps F through H.

- F. Remove shield cover by removing seven screws.
- G. Remove coils L6 and L7 and replace them with new 0.15 µH coils (240-1562-000).
- H. Remove capacitors C40 and C45 and replace them with new 4 pF capacitors (912-4141-080).
- I. Mark RWK REV G on the A5A2 card.
- J. Reassemble the transceiver in the reverse order of disassembly.
- K. Mark SB 3 on the service bulletin information chart. If the transceiver does not have an information chart, install a chart (280-3778-010) near the nameplate.
