Rockwell- Collins | SERVICE INFORMATION LETTER

KWM-380 TRANSCEIVER (622-5093-001, -101) HF-380 TRANSCEIVER (622-3580-001, -101)

SERVICE INFORMATION LETTER 1-84

PRODUCT IMPROVEMENT

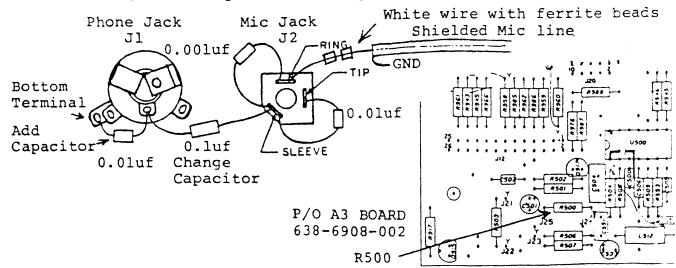
To remove RFI susceptibility on the microphone input and speaker talk-back during transmit.

High RF environment will cause distortion in the transmit audio and extreme audio distortion with the speech processor engaged. SSB undetected audio will be heard through the transceiver speaker.

On the rear of the front panel, add two ferrite beads to the white wire on the mic jack (part #288-1337-010). Change RF bypass C3 between mic jack and phone jack to 0.luf (part #913-3331-030). Add 0.0luf RF bypass capacitor to phone jack (part #913-3331-020). On the Receiver/Exciter A3 board, install a 6800pf bypass across R500 mic amplifier input resistor (part #913-5019-180).
