# CCA Introduction – 32S-3/3A Out of Band Transmission Concerns & Remedy

# The C20 Modification for the 32S-3/3A Transmitter by Don Jackson, W5QN

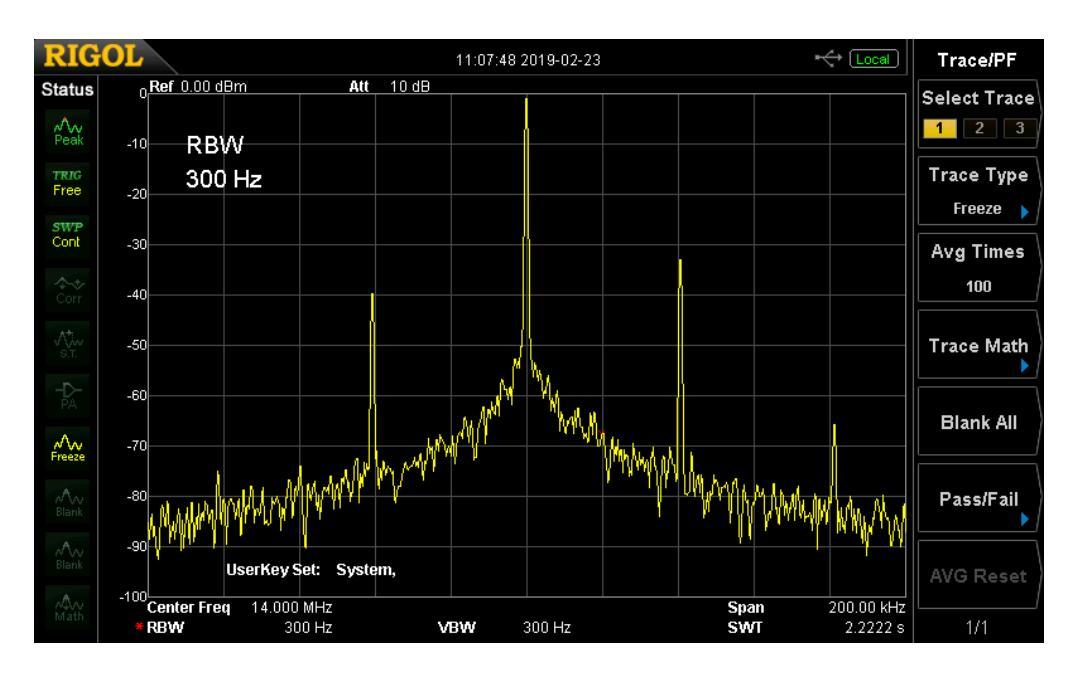
Figure 2 – RF Spectrum with .001uF C20

Observing Spur #3 on a spectrum analyzer, you will notice that it does not vary in frequency as the VFO is tuned, whereas Spur #2 and the desired RF output frequency will vary. This is an important point because it means that the out of band spur at 13.96055 MHz remains at this frequency, regardless of the setting of the VFO.

As can be seen in Figure 2, the spurs do not meet the 32S-3 specification of -50 dBc with a C20 of .001uF. Worse, the lower spur will be stationary, about 40 kHz out of band if the transmitter were tuned to 14.000 MHz. Figure 3 with the original C20 value of .01uF nearly eliminates those spurs, with remaining spurs well below the -50 dBc spec.

The bottom line is, if you have a .001uF installed for C20, replace it as soon as you possibly can. The slight increase in grid drive from the .001uF is certainly not worth the unintended consequences.

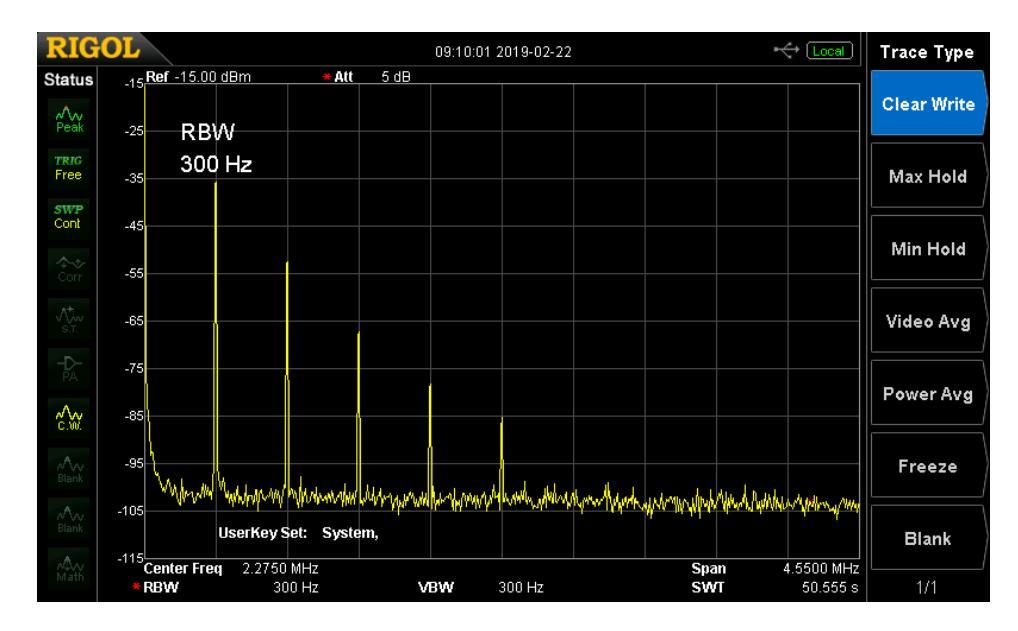
Figure 4 – BFO Signal with .001uF Showing Increased 5th Harmonic Level

Determination of the precise cause is not a trivial task. Analysis and measurements indicate that the problem is likely associated with increase in BFO harmonic content with the .001uF installed. Increased BFO signal may cause this, and another possibility is the terminating impedance the 1<sup>st</sup> Mixer sees with a .001uF C20 vs. a .01uF C20. The cause is likely a combination of factors. A likely "smoking gun" can be seen in Figures 4 and 5. These are spectral plots of the crystal BFO signal as measured at the 1<sup>st</sup> Mixer BFO input port, V4 Pin 3. Figure 4 was with a .001uF, and Figure 5 is with a .01uF.

Note that the fundamental of the BFO is about 8 dB higher with the .001uF installed. This higher BFO level with the .001uF is due to the lighter loading of the BFO oscillator. The lower level of the BFO with the .01uF installed likely contributes to the lower spur level. Of particular importance is the magnitude of the 5<sup>th</sup> harmonic. Recall from earlier in this article that the 5<sup>th</sup> harmonic of the BFO is a key contributor to the 2\*VFO minus 5\*BFO mixing spur. In the above figures, we can see that the 5<sup>th</sup> harmonic of the BFO is about 13 dB lower with the .01uF than with the .001uF.

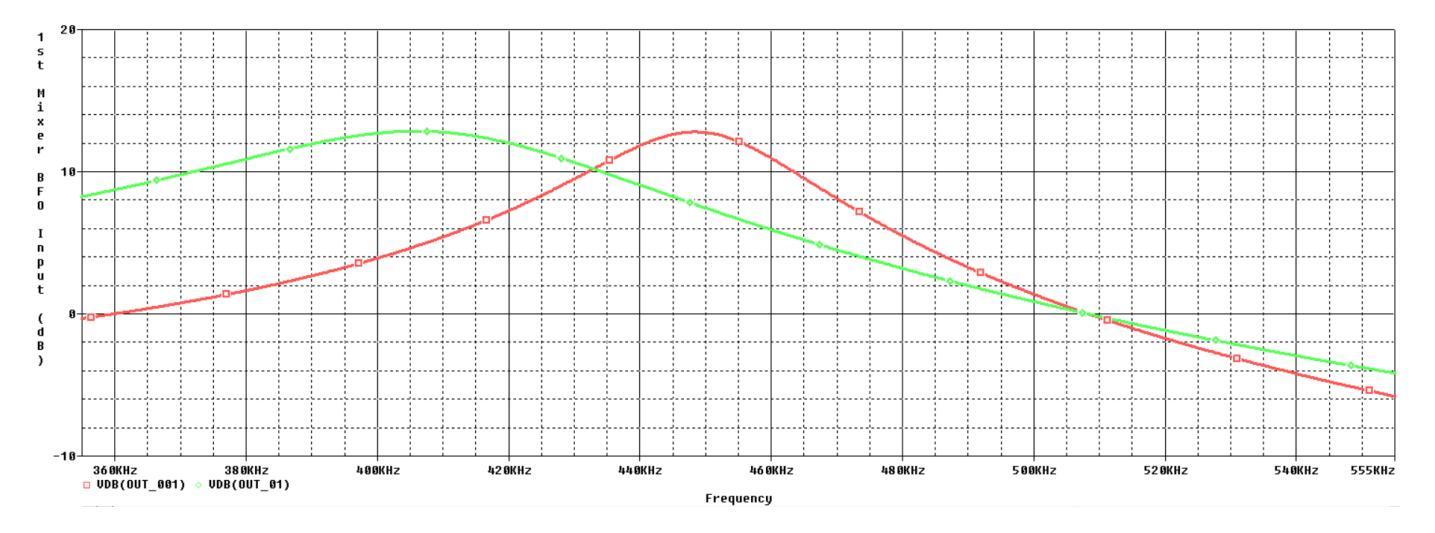
Figure 6 – Spice Simulation of the BFO Plate to 1<sup>st</sup> Mixer Grid Circuitry

As Figure 6 indicates, the simulation predicts that changing C20 to a .001uF increases the BFO drive to the mixer by about 5 dB at 455 kHz. Note that this is only a simulation, and behavior in the actual 32S-3 is highly dependent on the exact component values, particularly the LC components connected to the plate of the BFO tube.
