OFFICIAL JOURNAL OF THE COLLINS COLLECTORS ASSOCIATION

First Quarter 2010  
International Issue

## **The Practical Aspects of Using Military HF SSB Equipment On the Ham Bands**

*Service Line - The Care & Feeding of Your 30L-1*

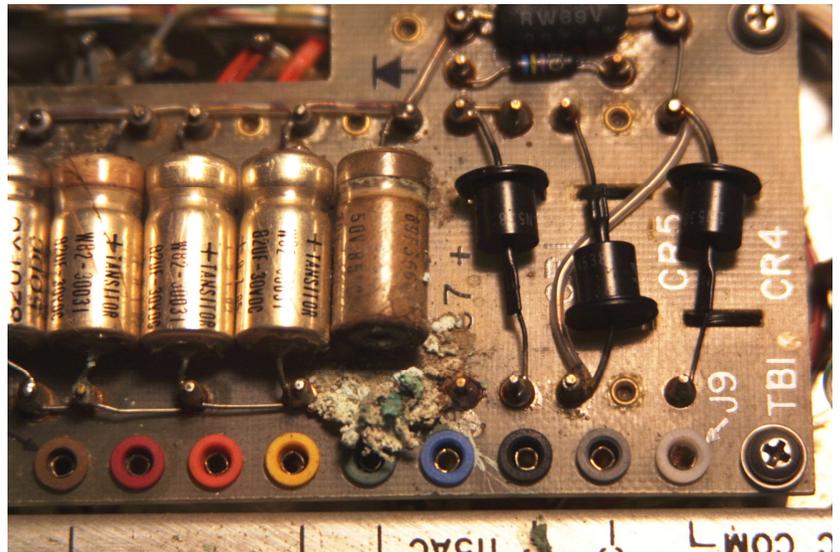
Figure 1. Time related Tantalum leakage

- 2) Electrolytic and tantalum capacitors are used everywhere in almost all of the modules. My experience is varied and I have one URC-32 in which all the capacitors are still good, and one KWT-6 that needed over thirty tantalums and electrolytics replaced.

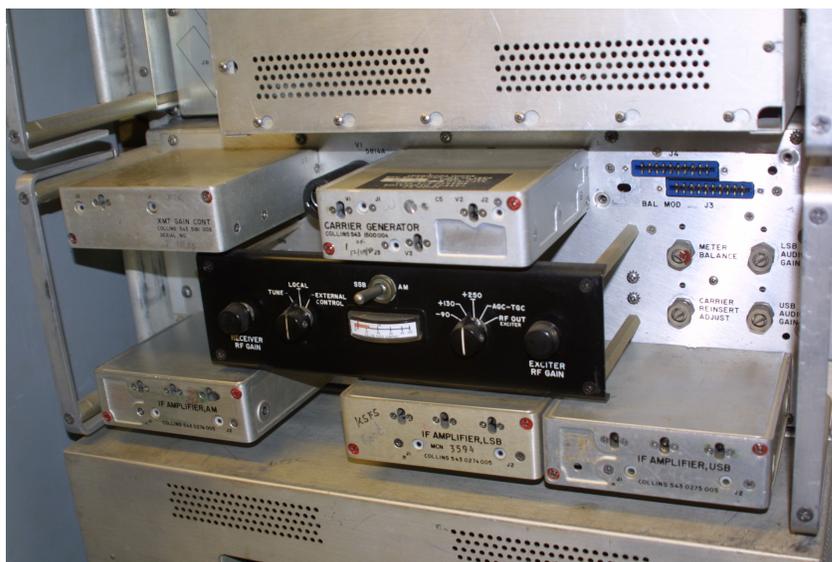
**Figure 2. SSB Generator Chassis with the Balanced Modulator Module Removed**

- 4) If you are starting on a set that has not been in service for a while, a complete disassembly is probably in order. Module interconnects are either PCB edge connectors, or D-sub connectors, and the simple act of removing, cleaning, and re-installing works wonders. Use a good pencil eraser on the edge connectors, followed by DeOxit and then just the DeOxit on the D-sub connections.
- 5) Troubleshooting is relatively easy, due the modular nature of the radio. Most assemblies serve a simple, specific, well-labeled purpose. Because of this, most modules can be operated and aligned by themselves on a reasonably well equipped bench. (You likely wouldn't be contemplating a radio such as this if you didn't have one, right?)

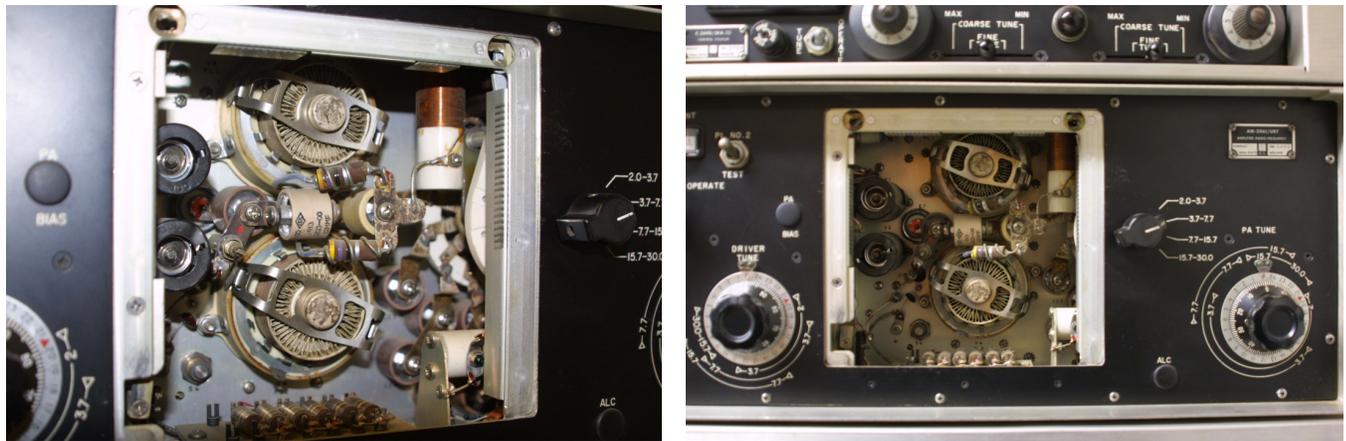
**Figure 3. Two views of the RF Power Amplifier Showing the Very High Packing Density**

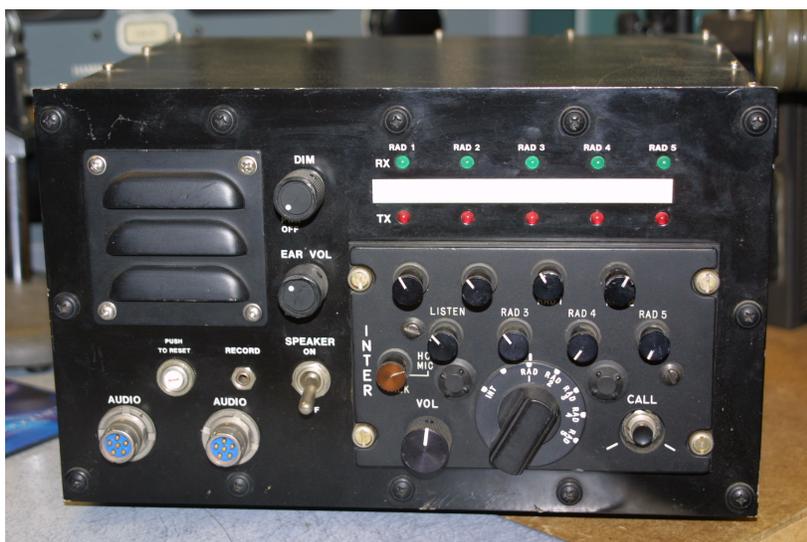
**Figure 4. AN/AIC-25 Interphone Control**

I operate my URC-32 in a semi-remote fashion. It, along with a KWT-6 and a couple of broadcast rigs, are positioned about eight feet from my operating position. It is a good idea to have a handset connected to the rig for tune-up, unless it (the rig) is positioned at the operating position. I have a rather unique audio system consisting of an AN/AIC-25 aircraft interphone box, which allows me to monitor any or all of ten receive sources, and select any one of six transmitters. The AIC-25 has transformer isolated, amplified microphone and receive circuits, and also has a very nice audio AGC circuit.

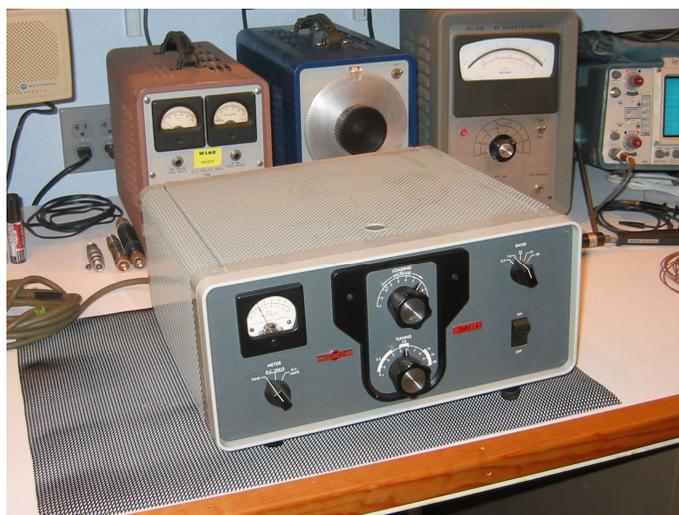
**Figure 2. Serial # 12770 is waiting in the exam room Doctor, but there seems to be something wrong with his foot and he hasn't bathed in months.**

I know that this is more general, but here are a couple of hints on how to get the case off of that heavy guy without damaging the paint or the unit. This question comes up from time to time and doing it wrong on a 30L-1 can result in much paint scratching, especially on the trim ring.

Put a soft towel down on your work space, and carefully - keeping the lid under control - turn the unit over on its top on the towel. Remove the 4 Phillips screws that hold the feet on the bottom of the case/chassis. Now, roll the unit back over right side up and with the panel to the left. Open the lid and remove the two short flathead Phillips screws that

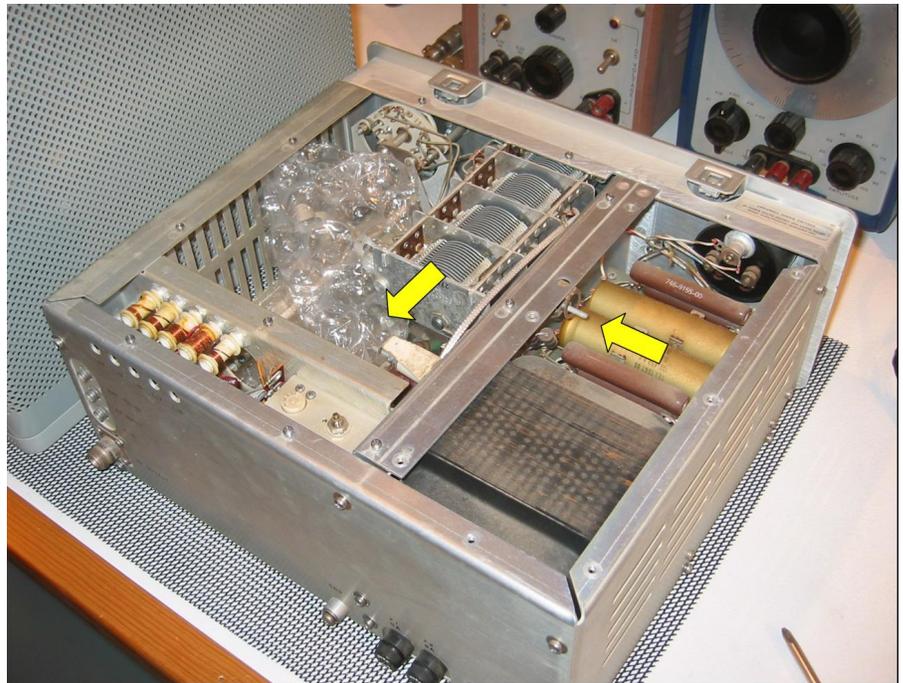
**Figure 3. Covers off and HV Shorting Switches, Or Interlocks Annotated**

covers of the PA tube and HV compartments. Notice that there are spring loaded shorting interlocks that short the HV to ground when the covers are

off. There are two on the top and one on the bottom. I say that because 30L-1s are often damaged by inexperienced repair efforts that involve running the RF amp with these covers off. First, try to never do that and if it is absolutely necessary and you are experienced at debugging HV equipment, then these shorting interlocks need to be defeated TEMPORARILY while the trouble shooting proceeds. This can be done by slipping a piece of heavy high voltage rated heat shrink over the screw in the center.

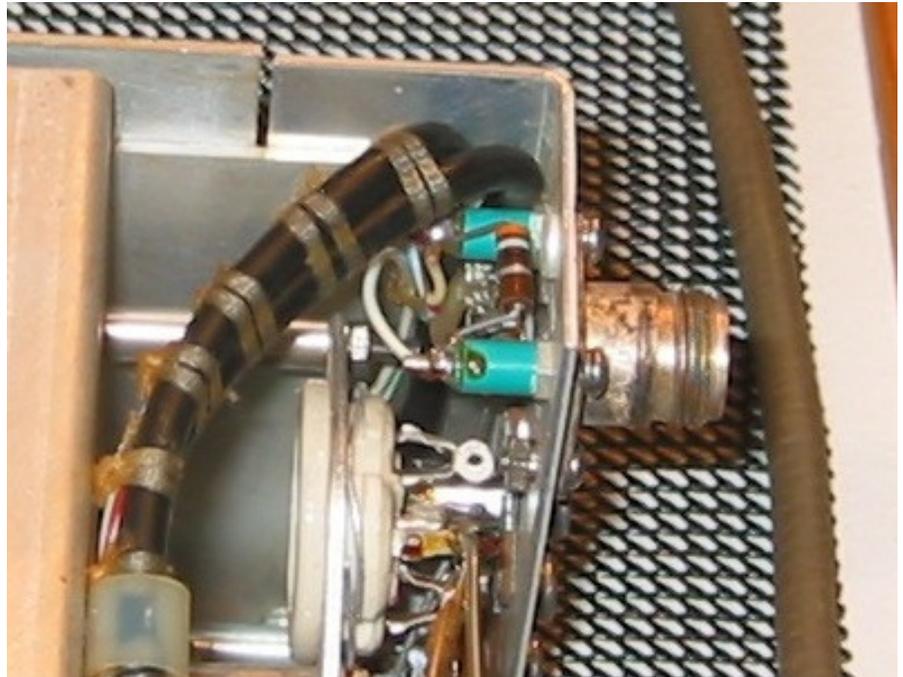
**Figure 4. R28 Bias setting resistor hiding behind the RF Antenna N Connector**

NOTE: There are a lot of folks that will tell you to change R28 to at least a 1 watt resistor and that the original ½ watt specified in the SB3(A) is not big enough. The bias voltage is around -3.0 volts. When the antenna relay is pulled in (R28 grounded) a quick  $V^2/R$  power calculation will tell you that this resistor is only dissipating a quarter watt.

When the antenna relay is not pulled in, there is no current in R28.....So, why are folks upping the wattage when they find it blown? I think Collins engineers knew exactly what they were doing here and used a half watt because it was enough UNLESS the grid came up in voltage because of a tube short. In this case, what do you want to blow here? Without the below mentioned modification, there is some justification for a hefty R28 to “clamp” the relay supply during a failure. In fact,

with the MOV protection mod recommended, R28 will never see more than a half watt of dissipation. I leave this resistor at ½ watt. Now, finish this part by checking to see that R9 is 47 ohms and not 82 ohms. You may have to tweak this 47 ohm value to a bit higher to get the correct 110 mA idle current with today’s higher line voltage.

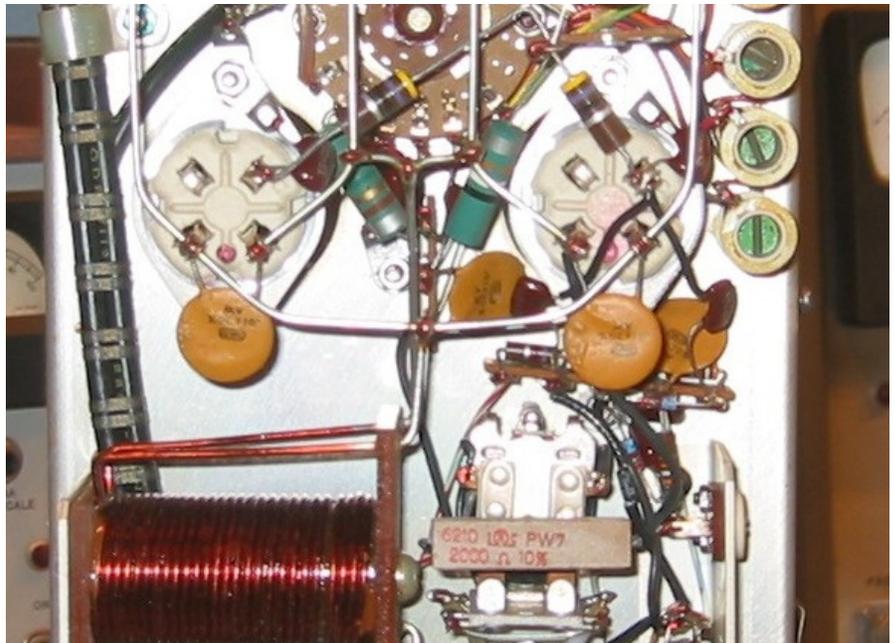
Figure 5. C2 shown to the right of the barrier strip before MOV Install

Now for "The exception that makes the rule!" While we are in the back end of the amp, I am going to make the one and only (non-destructive, completely reversible) mod that I recommend (no, insist on) in a 30L-1. Locate C2, a disc ceramic 0.01 mfd cap that is just to the right of the 47 ohm star connection of grid bias through the RF choke L3. Physically, C2 is on a three lug (center ground) terminal strip that is located just to the right of the tube sockets looking at the back of the amp while it is lying on its bottom. C2 lies flat against the chassis going from the right outside terminal to the center ground.

Install a bidirectional surge suppressor rated at 20 amps and 130 to 180 volts. It will install in the mirror lower position on the terminal strip flat to the chassis and is non-destructively tacked across C2. In the case of a plate to grid short in one of the 811As

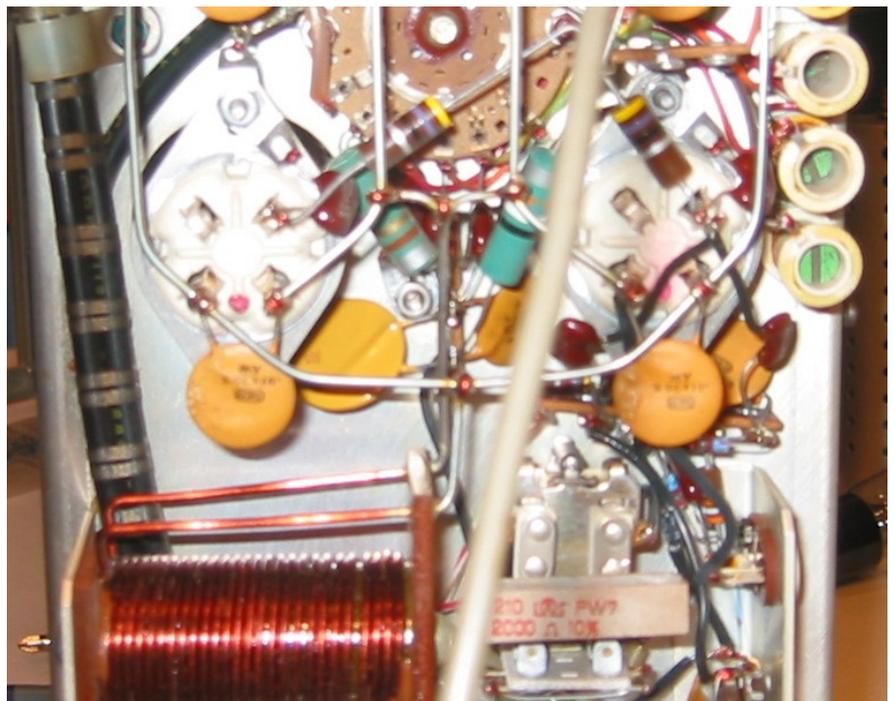
Figure 6. MOV shown to the left of the barrier strip after MOV Install

(not uncommon), the MOV or surge suppressor will shunt the plate voltage to ground and save the bias supply, including the transformer winding and also save the relay. Good Job! It will possibly die in the process and will short to ground which hurts nothing and then can be easily and non-destructively replaced. As they say at Am Ex, Don't leave home without it. Note: This mod is highly recommended by Dennis Brothers who is still an authorized Collins repair station and ran the internal repair facility at Collins, Cedar Rapids.

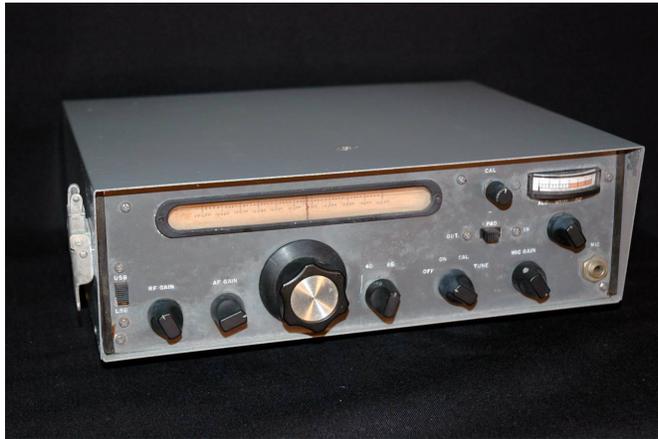
Last fall Dennis Day, W0ECK, donated to the Rockwell Collins Museum several artifacts related to Collins Amateur Gear history. One item was a small homebrew transistorized receiver-exciter designed and built by Ed Andrade, WODAN. The unit was well built but suffered some deterioration from many years of garage storage. Accompanying the unit was a mailing tube containing the hand-drawn schematic and chassis layout. The drawings were dated Jan. 2, 1961 and had Ed's initials on them.

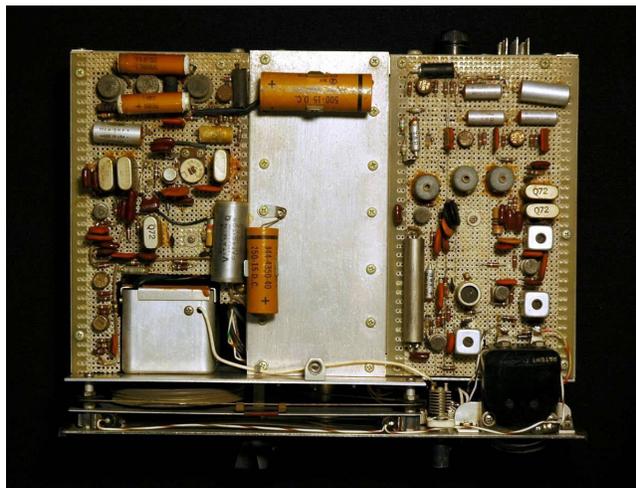
**Figure 2. Top of the chassis/breadboard view of the early transistorized mobile rig built by Ed Andrade, WODAN-SK**

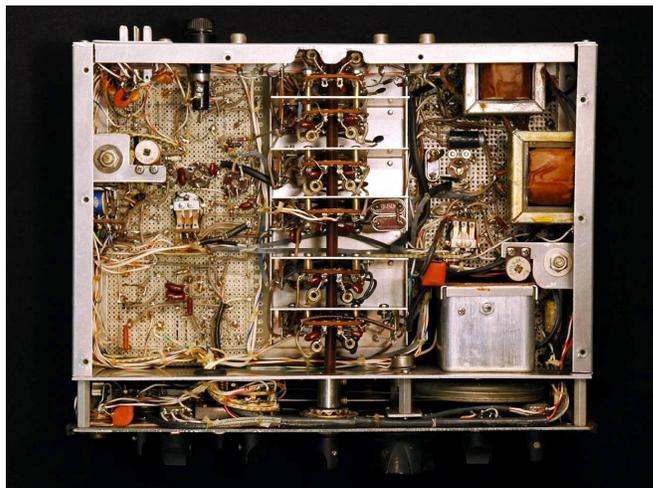
**Figure 3. Under chassis view of Ed's Critter prototype showing the very high level of technical excellence involved in this "home" project**

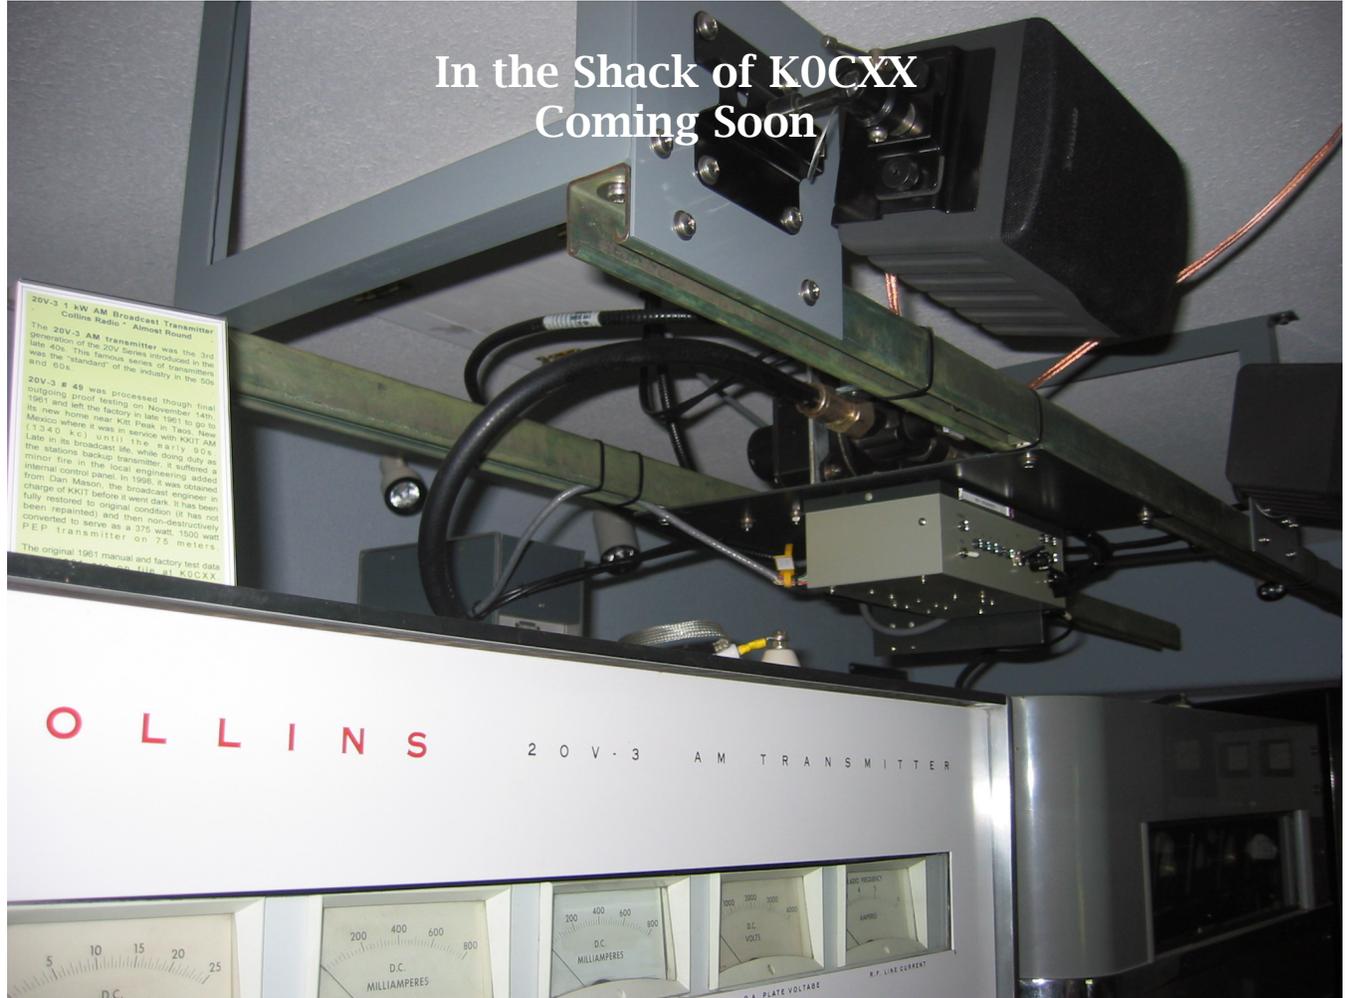
**Overhead cable tray, ceiling wire plenum entry and make-up for all cables coming to the 1 kW Broadcast Transmitters. This kind of approach to the station configuration may be why it took 1 1/2 years to get this all going..... Do you think?**
