**An ARTICLE on CARE OF YOUR 30L-1**

## The Care and Feeding of Your 30L-1 and Other Pertinent Trivia

de Bill Carns, N7OTQ/K0CXX

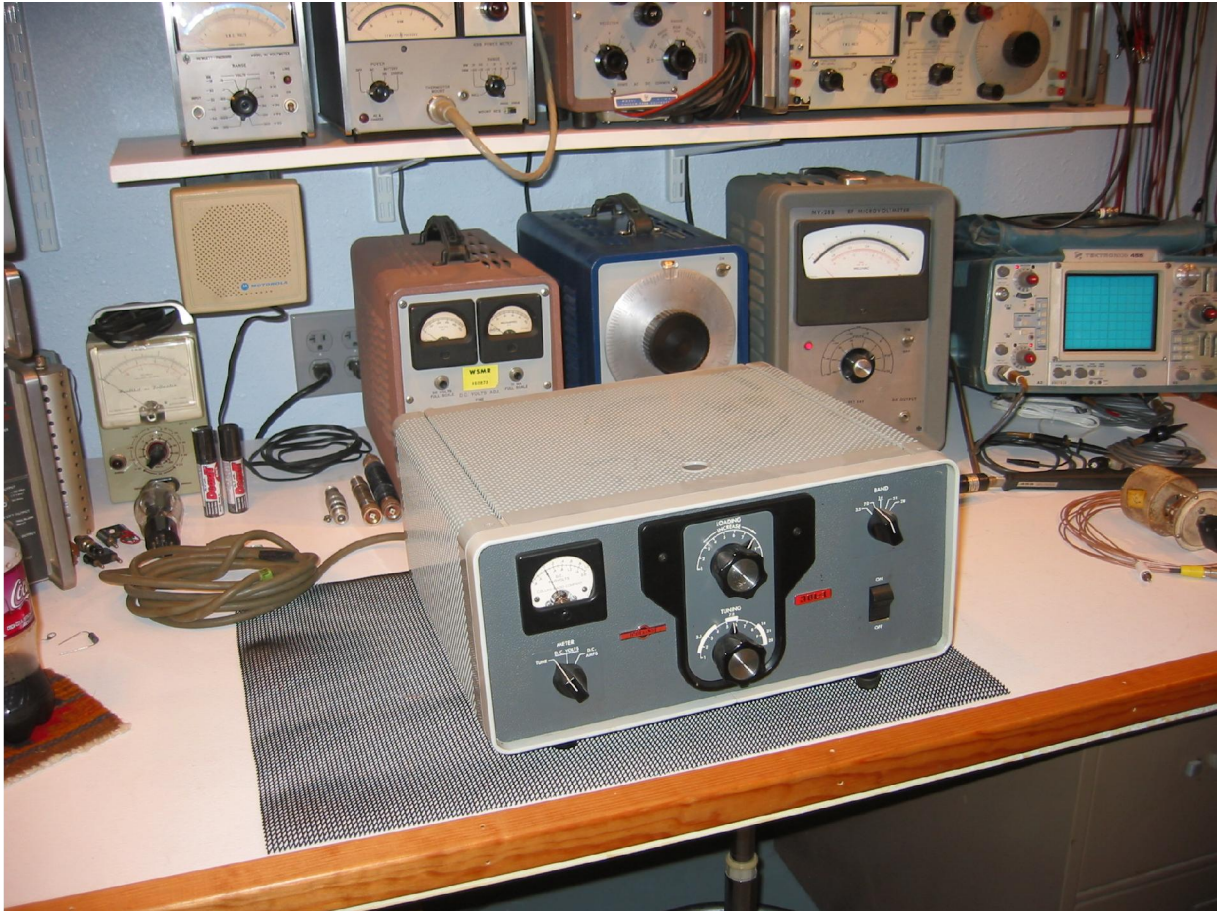
**Figure 2. Oh Doctor, Serial Number 12770 is waiting in the exam room**

But there seems to be something wrong with his foot - and he hasn't bathed for months.

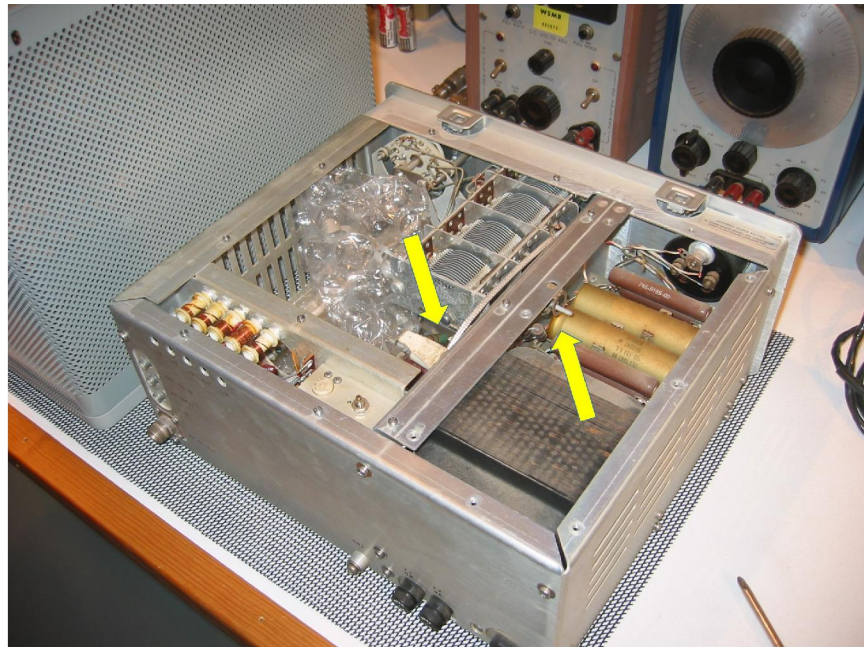
Remove the bottom and 2 top covers of the PA tube and HV compartments. Notice that there are spring loaded shorting interlocks that short the HV to ground when the covers are off. There are two on the top and one on the bottom. I say that because 30L-1s are often damaged by inexperienced repair efforts that involve running the RF amp with these covers off. First, try to never do that and if it is absolutely necessary and you are experienced at debugging HV equipment, then these shorting interlocks need to be defeated TEMPORARILY while the trouble shooting proceeds. This can be done by slipping a piece of heavy high voltage rated heat shrink over the screw in the center.

**Figure 3. First surprise – No tubes.** I forgot that Mister Thorough removed the tubes and padded the plate clips and braid before moving....Hmmmmmm, Time Out! ... and it is tube hunting time. With the current cost of 811As, read that PANIC time!
