The Signal

OFFICIAL MAGAZINE OF THE
COLLINS COLLECTORS ASSOCIATION
Q1 2018 Issue #89

Collins Radios in Cold War Jeeps

The MRC-83 (The M38-A1 Jeep and TRC-75 Radio)

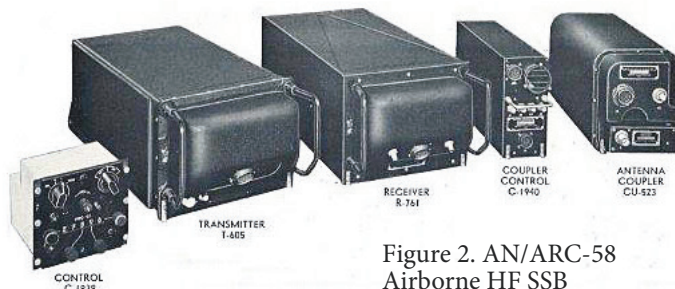
Figure 2. AN/ARC-58 Airborne HF SSB Communications System.

receiver-exciter, power amplifier, antenna coupler, antenna coupler control, and control head(s). This system provided 28,000 upper and lower SSB channels over the 2-30 MHz range, with a power output of 1kW PEP. It operated from the aircraft's 115VAC, 3 phase, 400 Hz bus. The system was very easy to operate; the crew member simply selected a frequency, and the servo-tuned radio came up on frequency, and after a brief tune cycle, was ready for operation. In addition, the ARC-58 could support independent sideband operation, so RTTY could be supported as well.

The first system that would exemplify the systems approach to SSB equipment design was the AN/ARC-58, intended for SAC's new B-52G Stratofortress and KC-135A Stratotanker. This system consisted of five basic line replaceable units (LRUs):

The ARC-58 would end up equipping a majority of SAC's B-52 assets, serving well until replaced by the Collins AN/ARC-190 in the eighties. As a footnote, the RCA built AM/CW AN/ARC-21, which had equipped postwar bombers and tankers, was modified for SSB in the latter fifties/early sixties, resulting in a new designation AN/ARC-65. It equipped a few older B-52s, and KC-97/ KC-135s. Suffice it to say it was not as advanced (being designed at the close of WWII), and had a considerably lower MTBF. Not to deride it excessively, it was a magnificent piece of technology for its time. It left service in the seventies, replaced in some cases by either the AN/ARC-58 or Collins 618-T, until aircraft were retired or modified with the installation of the AN/ARC-190.

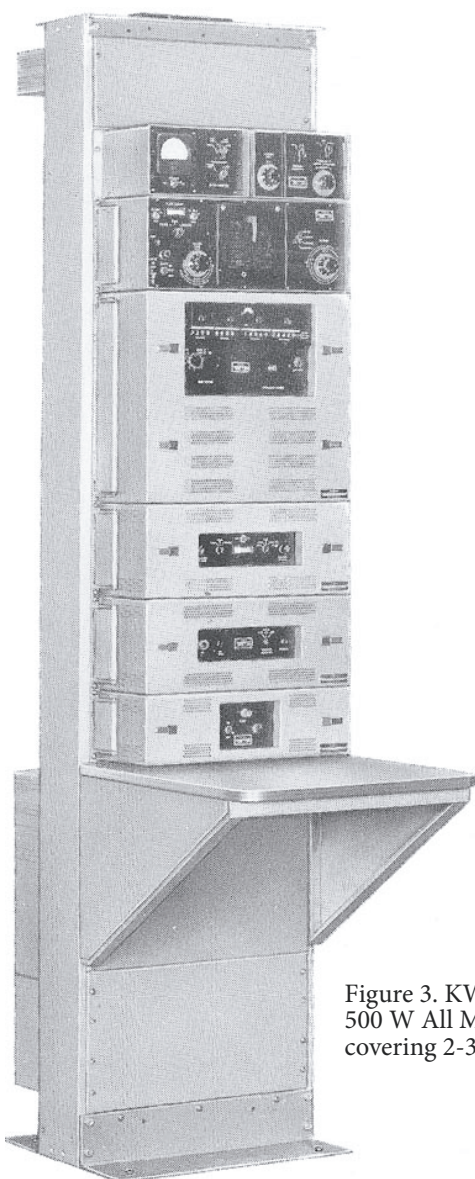
Figure 3. KWT-6
500 W All Mode Transceiver
covering 2-30MHz.

An AC power supply was fitted, along with a forced air cooling plenum that metered cooling air as required to each panel unit. The KWT-6 could contain an internal 500W PA, and even an internal antenna coupler, or it could be used as a 100mW nominal exciter to drive any of a number of external PAs from 2 KW to 50 KW. A specific model of the KWT-6 system was built for the Navy, designated as the AN/URC-32, it contained the internal 500W PA, with a remotely tuned antenna coupler. It tuned in 1 kHz increments but was later produced (or modified) with a 100 Hz interpolation oscillator to provide 100 Hz tuning increments. It was widely deployed in submarines as well as surface vessels, serving well into the eighties and even nineties.

In order to talk to all the airborne assets, a ground station was needed. The KWT-6 filled this need, and was deployed to communication stations around the world, including SAC headquarters at Offutt AFB, NE. The KWT-6 shares the basic frequency generation scheme and receiver as the ARC-58, but rather than being servo tuned, was manually tuned using a frequency selection knob and band switch. The packaging was in a relay rack, with rack units holding several chassis containing the familiar modules that became synonymous with the Collins name.

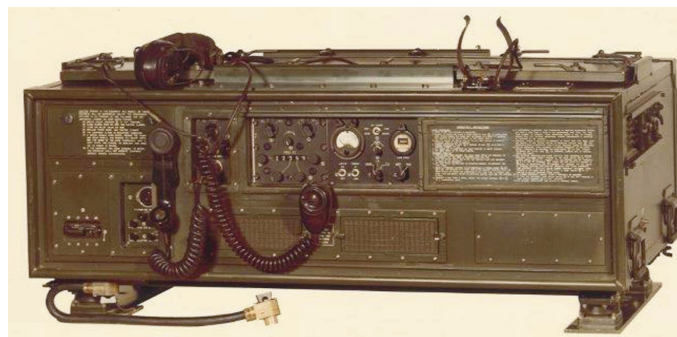
Figure 4. AN/TRC-75
HF SSB Communications System based on
the ARC-58 units adapted for mobile service.

The TRC-75 was mounted across the back of an M38A1 Jeep, and a Mite teletype unit was mounted in the passenger seat position as well. A large 400Hz inverter powered from the 100A 28VDC charging system provided the three-phase power for the radio. This gave The USMC (and later the Army and Air Force) the ability to forward position a HF teletype link wherever they chose. The entire jeep was known as an MRC-83. Using a long wheelbase M-170 Jeep and adding a Collins ARC-55 UHF radio resulted in an MRC-87, widely used as a forward air control Jeep in the early years of the Vietnam conflict. The TRC-75 was later fitted to the M-151 MUTT and was used by the USMC through the first Gulf War period. Not bad for a thirty-year-old radio!

In what was probably a natural progression, the ARC-58 LRUs were installed, along with a RTTY modem, in an aluminum casket-like enclosure and given the nomenclature AN/TRC-75.

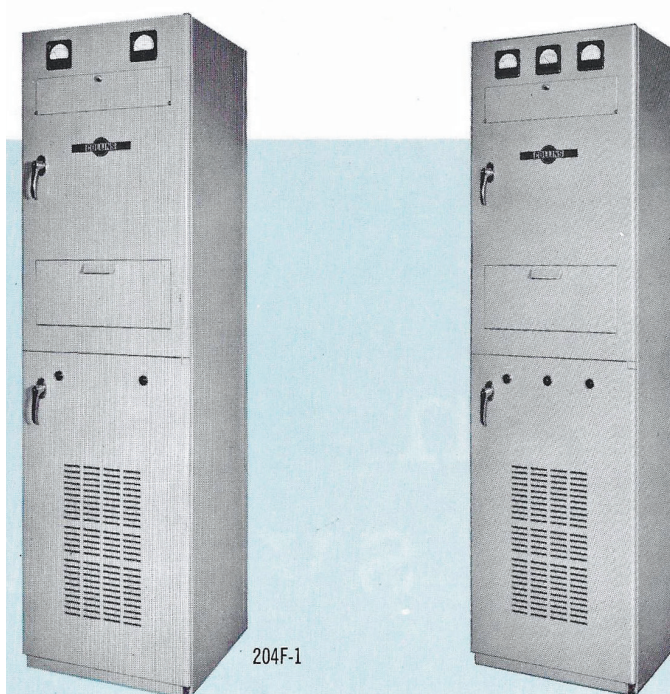
Figure 6. 204F and 204H
2.5KW PEP or CW linear amplifiers using a pair of
4CX1000As. The 204H adds the autotune function.

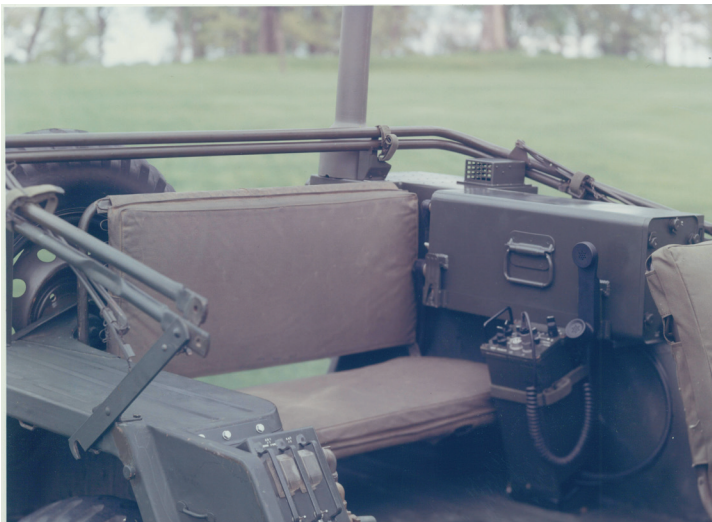
Here is a 718U-2 (AN/VRC-80) in a different M151 jeep. The 718U-2 is also a 400W HF radio, again built using URG-2 slices. The -2 version uses a separate 671U-1 receiver/exciter, which is shown next to the radio case and in front of the jeep's rear seat. Note that, with the separate 671U-1 receiver/exciter rather than an internal 671U-4A receiver/exciter, the 718U-2 main radio case is narrower than case on the 718U-2A pictured above. All the 718U-2 variants use the same power amplifier module & power supply module & antenna coupler case.

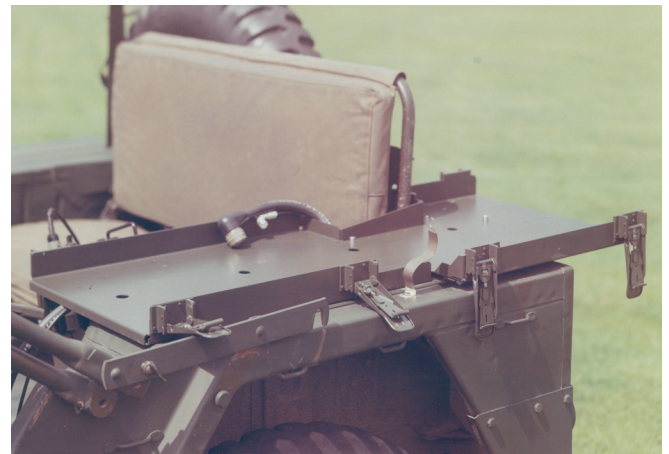
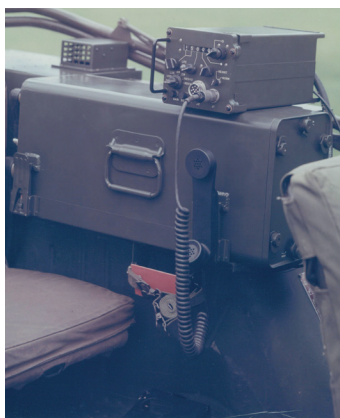
Another photo of the 718U-2 with a better view of the 671U-1 receiver/exciter. The 671U-1 receiver/exciter is also part of the 718U-1, where it is paired with the 100W 548S-1 PA/coupler. The 718U-1 was sold to the U.S. military as the TRC-169. The TRC 169 came with a rucksack frame for use as a manpack, where it was powered by a BB-451 silver-zinc battery. The TRC-169 also had facilities to mount in and be powered by a vehicle.

The mounting plate is a simple affair and attaches both the radio case and also the antenna coupler case to the jeep. It looks as if the antenna coupler case was specifically designed with a corner missing so that it the radio install would not require removal of the rear seat. It's a bad idea to have the antenna coupler sticking out further than the jeep's bumper, especially considering that the radio costs about 10X what the jeep costs.

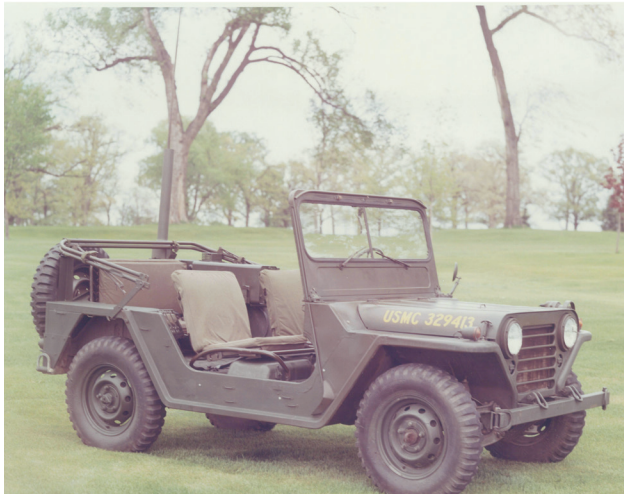
USMC 329413 is the hood number on this jeep, possibly it was loaned to Collins as "GFE" - Government Furnished Equipment. All the 718U-2 variants use a 548T-1 RF power amplifier and a 636X-2 power supply - the supply operates from +28VDC generated by the jeep's alternator. In a 718U-2, the PA & PS are inside a 718F-7 case, and in a 718U-2A the PS & PA are in a 718F-8 case along with the 671U-4A receiver/exciter.

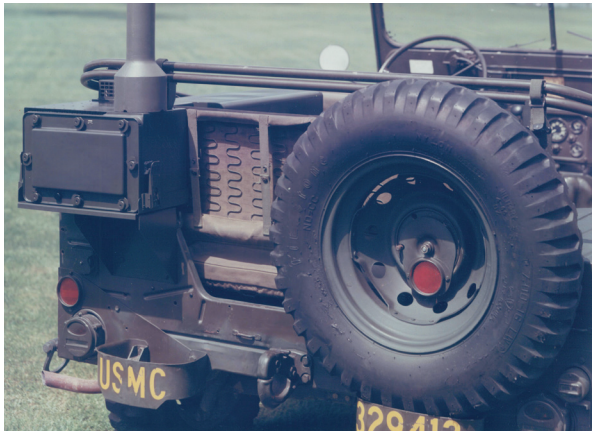
The antenna coupler used in these 718U-2 radios is a 490B-4. What's inside the waterproof case is just a 490T-2, which is nothing more than a 490T-1 with a fan. The whip antenna is an AT-1011/U - a 32' fibreglas whip - looks like only the bottom 16' was in use for these photos.

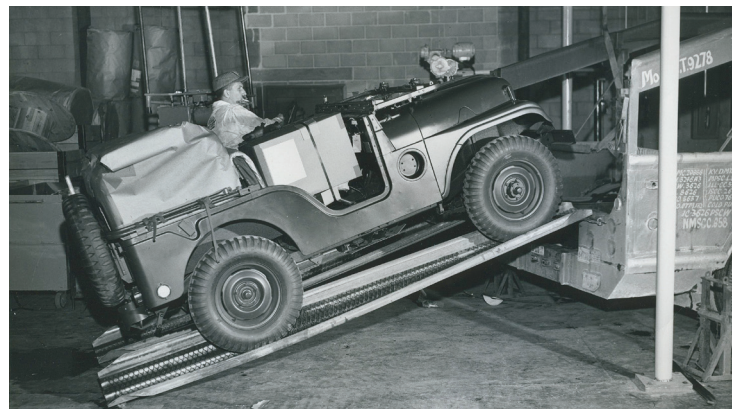
Still at the Alpha facility, here's a teamster type driving the finished product up onto a car transporter. Note that the TRC-75 install really flattens out the rear springs in the M38A1.

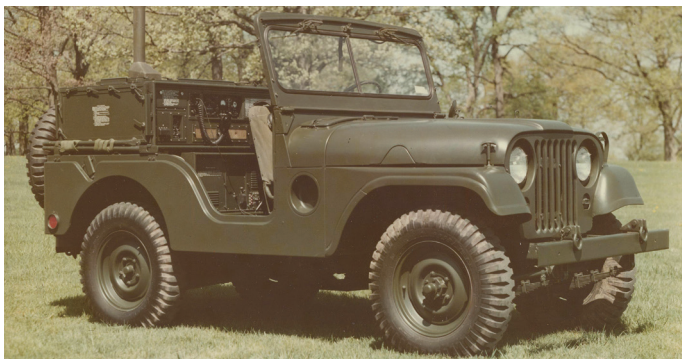
Publicity photo of a complete MRC-83 radio set, a TRC-75 installed in an M38A1 jeep. Visible underneath the radio is the power supply box carrying the PP-2352 inverter - the inverter runs off 28VDC and makes 115 VAC 400~ 3 phase power for the radio. On the front of the power supply box are controls for the inverter and also a rudimentary selftest setup for the inverter with lamps to give a go-no-go indication as to the health of each chopper transistor in the inverter. The MRC-83 first saw the light of day around 1960 - in those days it was quite a feat to put a 1kW automatically-tuned HF radio in a vehicle. I saw over 2000 TRC-75 radio sets come up for disposal at DRMO Barstow in the early 1990s, and I guess that most of those radios were installed in M38A1 jeeps just like this one - the 1960s was an excellent time to own stock in the Collins Radio Corporation.

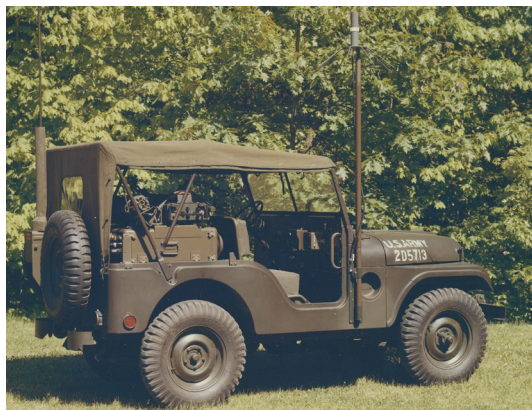
Another photo of the same M38A1 with MRC-108 electronics, this one with the canvas top attached and the vehicular UHF AM antenna erected.

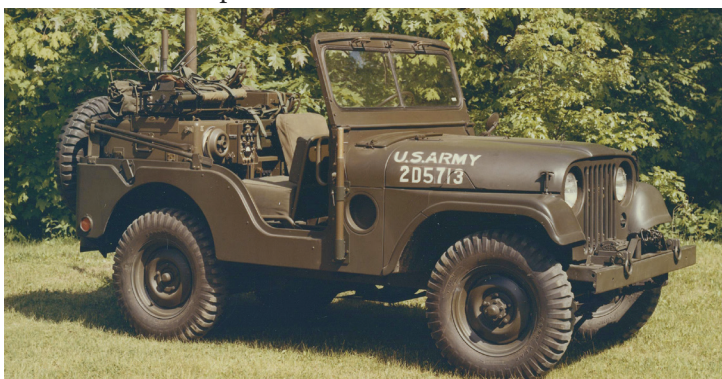
This appears to be some sort of MRC-108 prototype built in an M38A1 rather than an M151. Visible is the 618T-3 box & control head, with a PRC-41 with rucksack frame on top for UHF AM coverage. To the right of the 618T box is a PRC-47 with cover attached, and on top of that is the rear of a PRC-25. There is plenty of room on the M38A1 floor, underneath the 618T box and the PRC-47 and it looks like there are other radios under there. The PRC-25 & PRC-41 & PRC-47 are probably meant to be dropped off and operated 'on the ground'.

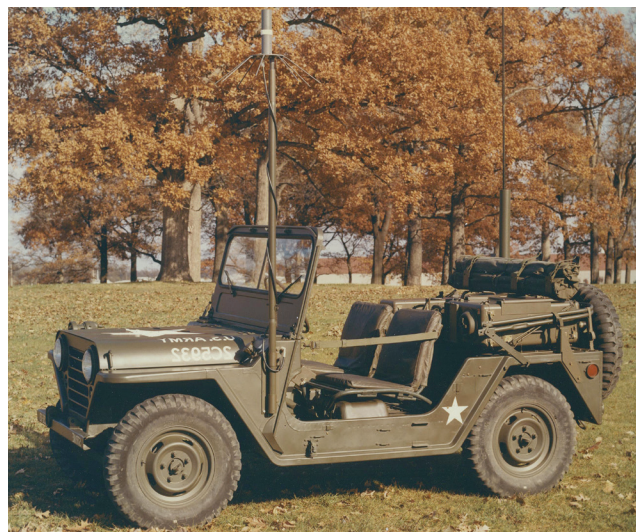
This looks to be an early MRC-108 in an M151, there is a 400W HF SSB radio using a 618T-3 with an 850 CPS teletype modem and 115 VAC 400~ inverter in the box on the right sponson. Usually a Kleinschmidt TT-4 sits atop the 618T-3 case - it is not present here. A 180R-6 antenna coupler is in the case on the left sponson. Since there is a UHF antenna on the jeep, I assume there is more radio gear in the jeep even though it is not visible in this photo.

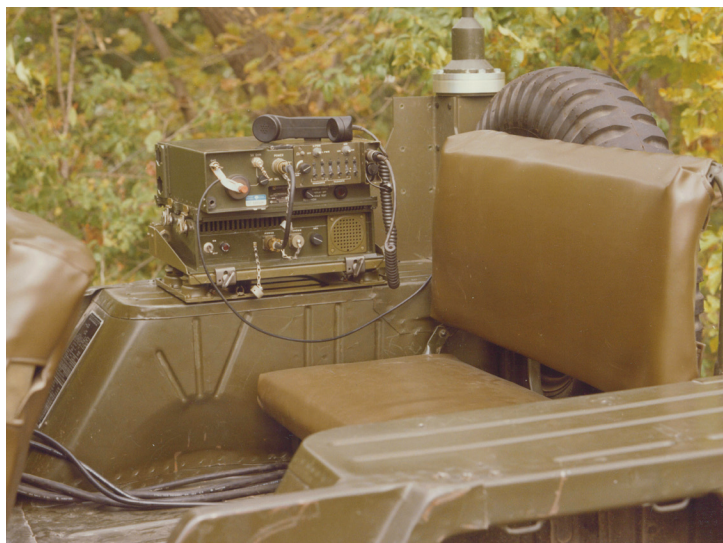
(RIGHT) This is a VC-120 installed in an M151 jeep. The antenna is an AT-1011/U and the base looks like something created by the engineering department for this photo shoot. The VC-120 aka GRC-220, this one has an early power conditioner, since the more common power conditioner units have the speaker on the left side of the front panel. The antenna post on the radio will accept a 15' whip antenna (like that used on the PRC-47), and the radio can be powered by a BB-451/U silver-zinc battery (like that used with the PRC-47) - the manpack version of this VC-120 radio is called the MP-150 or the 719D-15. Looks like the antenna post is jumpered to ground but the ANT SEL switch is still in the WHIP position, doubtless a radio silence precaution taken by the Collins Marketing 'droids.
