The Signal

OFFICIAL MAGAZINE OF THE COLLINS COLLECTORS
ASSOCIATION * Q3 2016 Issue #83

Rebuilding the 30S-1

30S-1 Bias Supply Overhaul

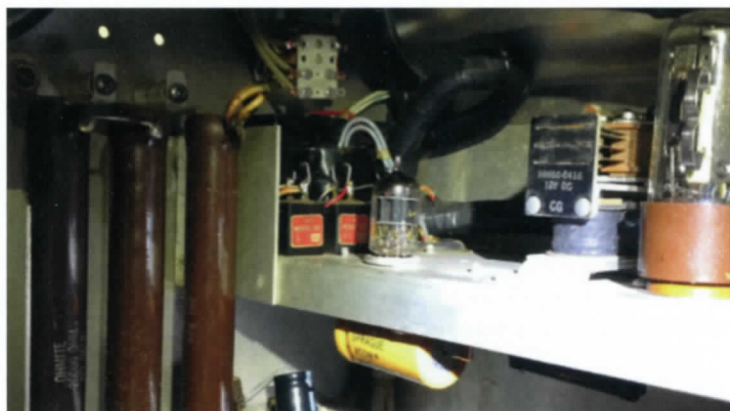
Figure 1. Rear of Relay and Bias Supply Shelf

I was looking at a scab-on job where the leakage from the original selenium rectifiers was still in play and thus (along with potentially bad caps) the lower bias output. I am being hopeful that the transformer is not damaged somehow. The shelf has to come out and some parts removed and replaced.

Figure 1 below shows the shelf in place and you can see those parallel installed diodes. Bad plan.

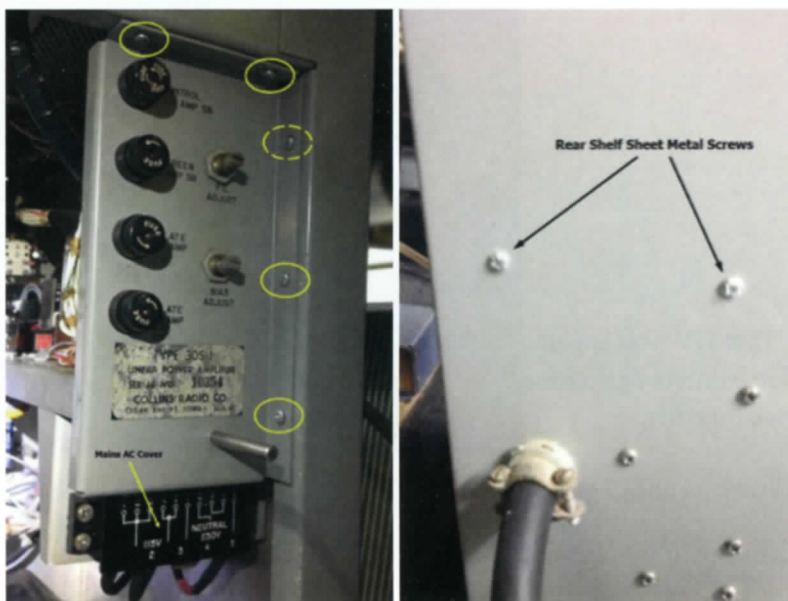
Figure 2 and 3 to the right (respectively)

2. Now, come around to the front and remove all of the outside panel attach screws (There are 5) except the upper right side screw. Just loosen that about half way.

3. Now, go around to the rear and remove the two rear inner lip sheet metal screws that you loosened before. The back of the shelf will fall down a bit but not far (held by harness and the front screw.)

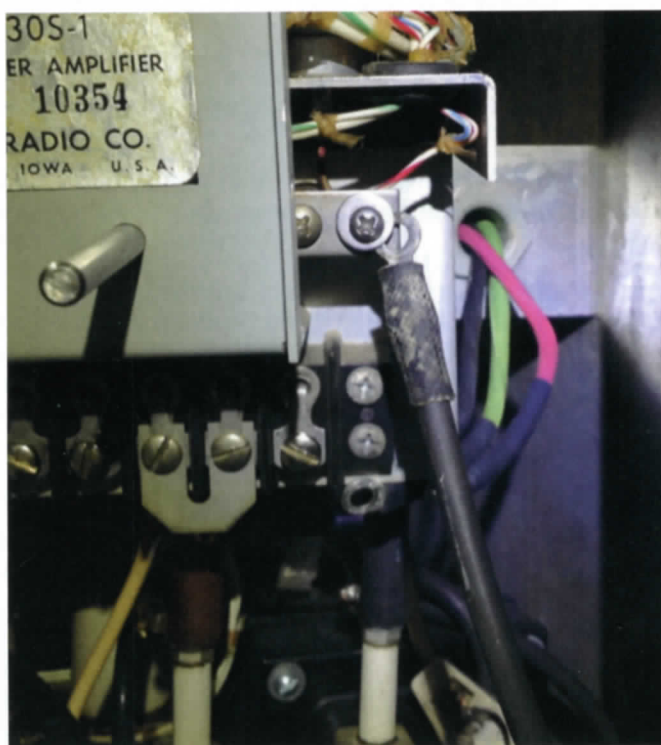
Figure 4. High Voltage wire here shown already unbolted and just clamped for picture

7. You will be looking at a High Voltage lead that goes to a screw terminal on the door "dead fall" shorting switch S206. That screw that holds the HV wire on the switch terminal bar is threaded into the bar so you can just temporarily remove the screw without worrying about a blind nut falling down somewhere. Remove the cable and then restore the screw in the threaded hole.

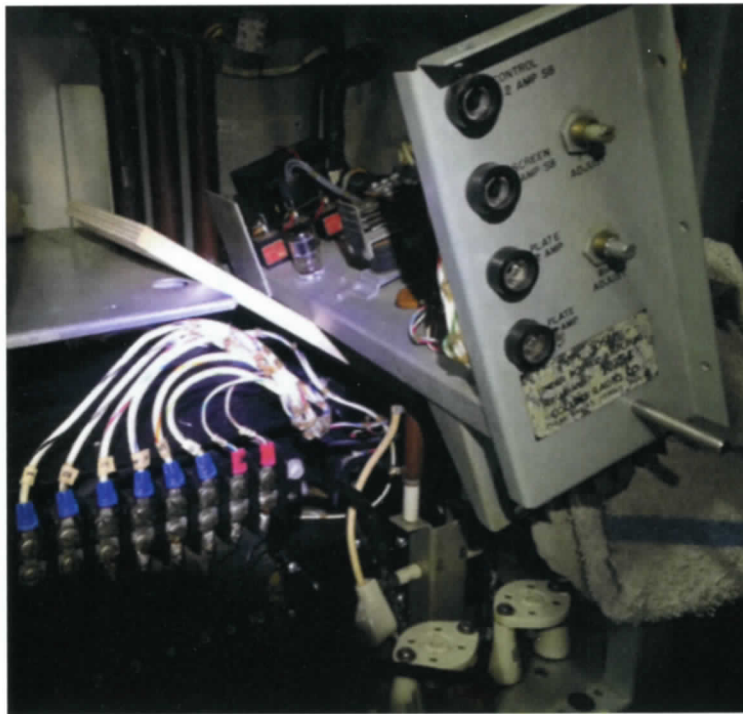
Figure 5. Shelf in position 4 or 5 inches out from frame & before harness release

8. That HV wire is going to want to flip back and hide behind the frame. Before it does that put about a 6 inch piece of blue painters tape around the cable up where it will show, so you will not forget to hook it back up when this all goes back together.
9. Now, go ahead and pull the shelf out until the face of it is about 4 or 5 inches in front of the cabinet frame.

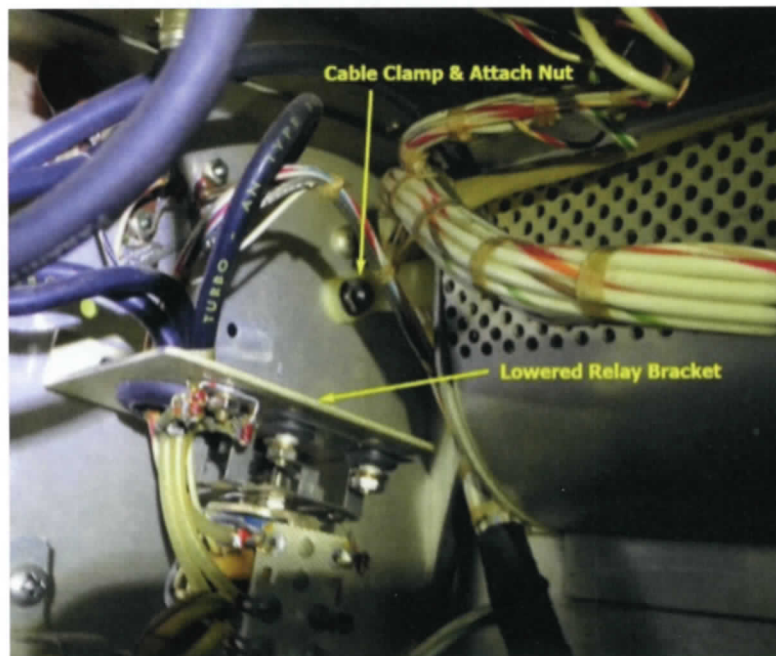
Figure 6. Rear Harness Cable Clamp & Attachment Nut

10. harness (that is keeping the shelf from easily coming forward any further) is running behind that intake air sheet metal that forms the right lifting handle. There is a cable clamp holding the harness back in that corner. We are going to take that off and it is not as bad as it looks.

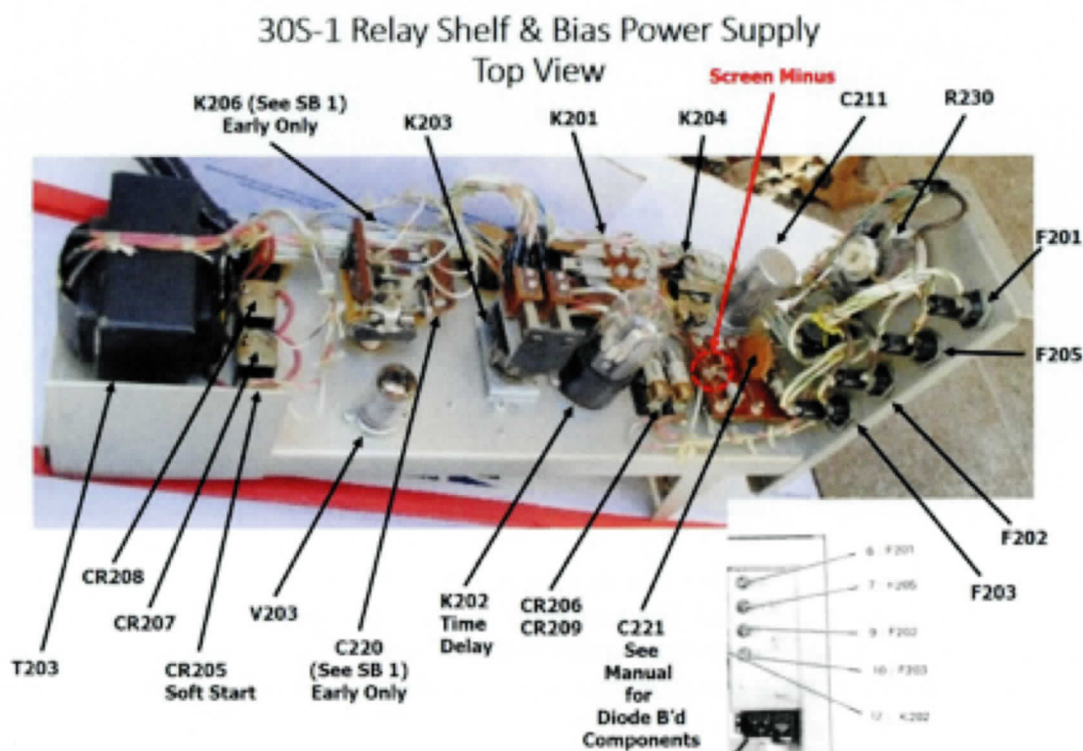
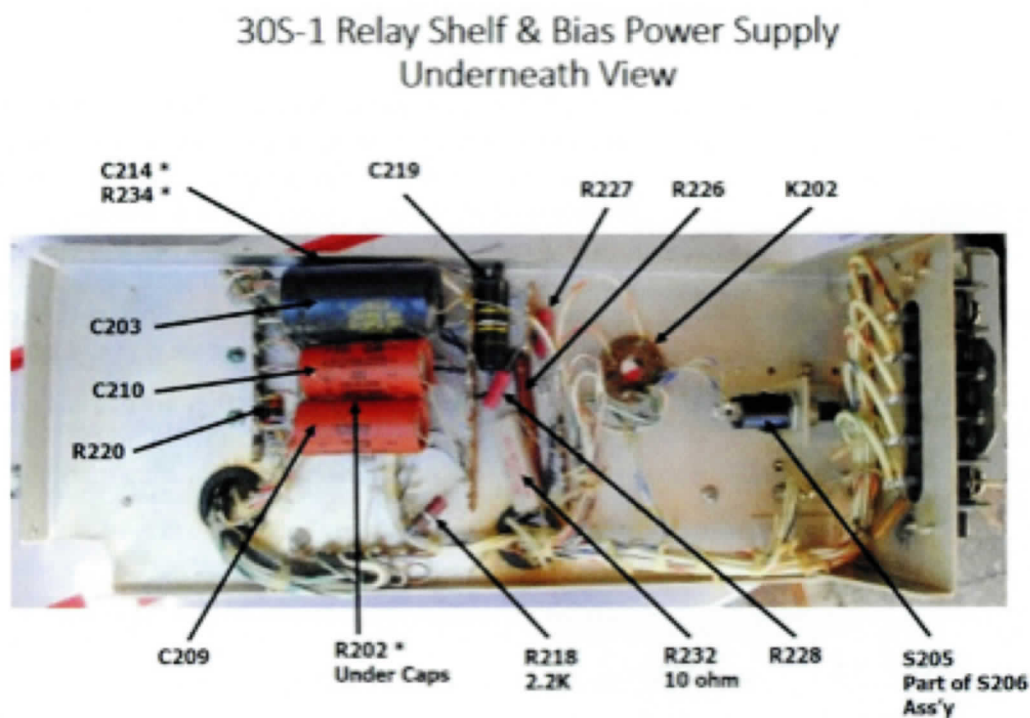
Figure 8. Annotated front view showing the shelf pulled as far out as it will go ~
Shown resting on a temporary rear wood shelf and front Styrofoam prop.

The shelf is now out where you can work on it and you are ready to start the bias supply repair. Figure 8 shows the shelf pulled all the way out (about 50% out of the cabinet) and resting on its temporary "bench" that spans from the 516F-2 shelf to a cabinet bracket on the right inner side panel.

For completeness here, I am also presenting better component placement figures than are available in the Collins manuals. For some reason, the manuals do not even show a bottom view of this shelf.

My thanks to Chris Farley, KC9IEQ for taking these good pictures of an early pre-SB-1 30S-1 shelf. Note that if you have an early 30S-1 that has had SB-1 accomplished in the field, there will be a terminal strip mounted in one of the removed K206 mounting holes. If you have a post SB-1 production 30S-1, there is no terminal strip required and the harness was redone to just run the wires on through.

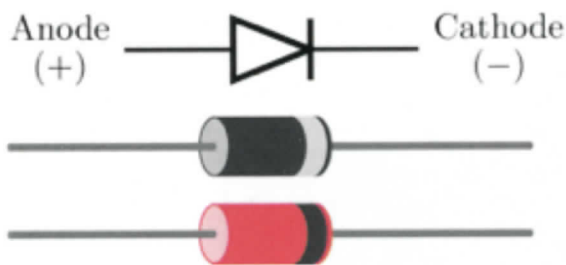
You should make note of a fossil marking tradition that dates back to the early days of electronics. If you look at any modern diode, there will be a band around the cathode end of the diode indicating that this terminal should be kept negative for forward conduction to occur.

Be aware that early selenium rectifiers were marked just the opposite. If you look at the red leads (secondary of the bias transformer T203), on the schematic for the 30S-1, they go to the cathodes of the two rectifier diodes, CR207 and 208. This is as it should be for a negative supply. BUT, if you look at the actual original selenium rectifiers in the amplifier, you will see that the red transformer secondary leads actually go to the terminal of the rectifiers that is marked with the + sign, indicating what would be - in modern

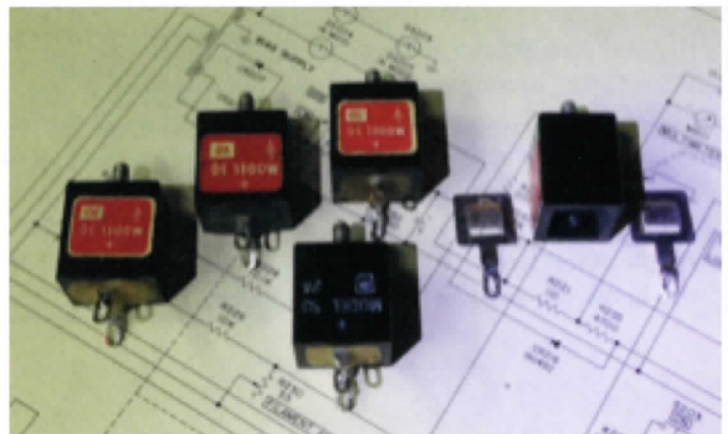
About those selenium diodes: Referring to the photo below, you can see that the original selenium (CR207 & CR208) is

contained and potted into a Bakelite black housing that has an embedded stud mount on the bottom and a cavity revealed on the top. The picture below shows several styles of the original Sarkes Tarzian Type 50 diodes as well as the same diode type after the innards have been removed. To the full right you can see the salvaged contacts that will be reused to solder in, and hide, the 1N4007 before we re-pot the cavity with a newer epoxy.

single selenium layer is about 1 volt at room temperature and the reverse breakdown is about 25 volts. To get the required breakdown for this application the Model 50 uses 8 "diode plates" for a breakdown of about 200V and thus a forward somewhere around 8 volts. This forward knee is pretty soft, so if you make a test pass with a VOM that uses 2 cells for the OHMS scale, then you are going to get some meaningful data – sort of. If you use one of the cheaper VOMs, and it uses just one cell for the OHMS scales, then all you will see for the S.T. Model 50 we are talking about is what appears to be an open diode.

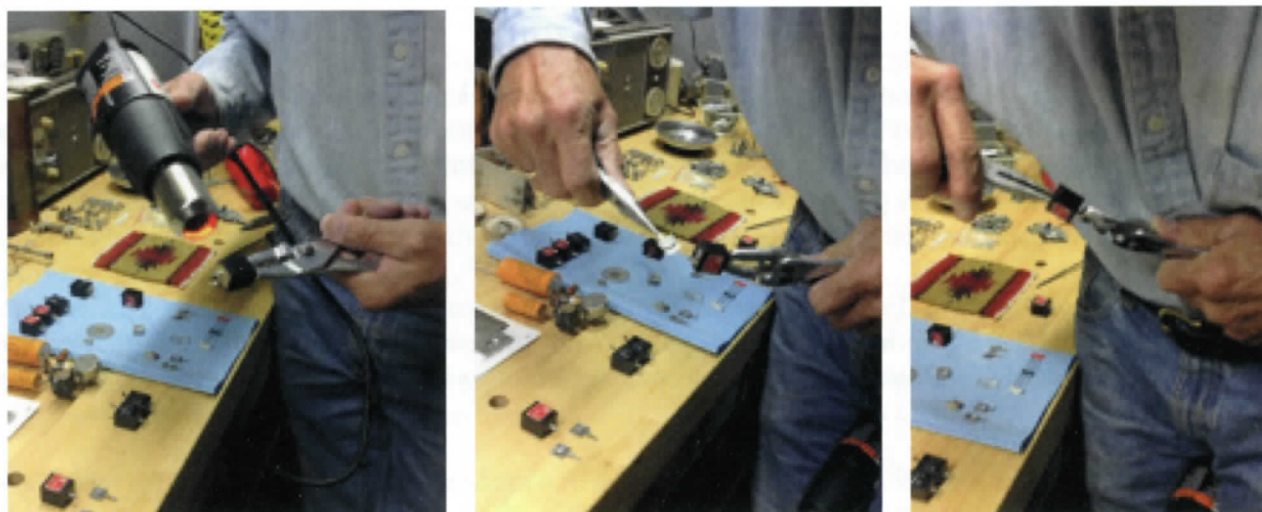
So, put a nut on that stud and use it to hold the diode with a pair of pliers. Then use your heat gun up close and personal (don't be afraid to toast the case) and heat the entire case up. Keep bringing up the temp and after a few minutes start tugging at one of the contacts with a pair of needle nose pliers. That potting compound will get powdery and lose its strength. It will not flow, but just give up the ghost. Pull out the contact straight up and work on the second one while you keep applying the heat. In the process of pulling the contacts out to be saved for later, the entire potting compound "cap" will usually just pop off.

After you have both contacts out and the top compound popped off, you will be looking at the selenium laminated (or layered) structure. Take the needle nose pliers (use fine ones) and grip down on either side of the pile of laminates and pull the entire structure out while the case is still hot. At this point you will have an almost empty cavity. Stop heating and start cleaning the cavity out - first using a small screwdriver and then a small pen knife blade. Almost all the powdered compound will come out. Now, it's time to put the new diode back together.

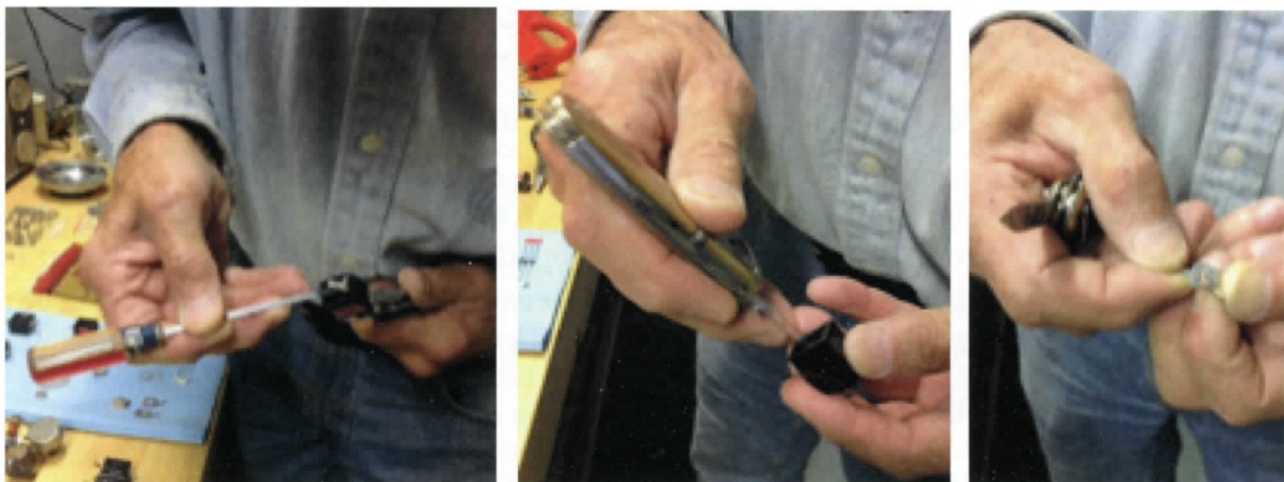
Here is a handy guide for keeping the temperature in the correct range. Bakelite blisters and starts to break down at 190 °C. The potting compound used on almost all of the Sarkes Tarzian selenium rectifiers breaks down at about 60 °C. If you touch something that is 50 °C, you can touch it, but not for long. If you touch something that approaches 100 °C, you will not be able to stay there at all. As you start heating the case of the old rectifier, stay away from the label side and rotate the diode through three sides starting with the gun about 5 inches away. Heat for a couple of minutes trying for absorption and soak uniformity. You do not want to get just the outside case hot. Then after a couple of test feels that will tell you where you are, close the distance down to about 2 inches and rotate faster. When you know you are over 50 °C, start pulling parts out.

Finish cleaning up the salvaged contacts by carefully warping them enough to pop out the locked-in old compound and then carefully bend them back so that they are flat. Leave the little leaf sticking out and parallel to the entire contact blade. If you have not already done it, use solder wick and remove any excess solder or wire from the lugs.

We are going to solder in a 1N4007 in such a way that one lead goes around the little pop-out locking blade close to the bottom of one blade and then the other goes around the other contact blade close to the top. All wires and the diode will be down in the cavity - soon to be buried in new epoxy. Form the leads so that the contact blades are just a hair wider than the cavity's short direction, and the diode is positioned from lower front to upper back diagonally across the cavity as shown in the next figure. Use smooth bends when forming the diode leads as this makes the assembly easier to adjust for width and parallel contact lugs. Solder it up and then test fit the new diode contact assembly in the cavity. Remove it and set it aside. Observe the photo of the diodes being soldered for approximate lead length. Too short is worse than a bit too long.
