EQUIPMENT SERIES: 30L-1

BULLETIN No. 5C/Revised

SUBJECT: CORRECT POWER DISSIPATION RATING OF R15 AFTER SB-3A CHANGE

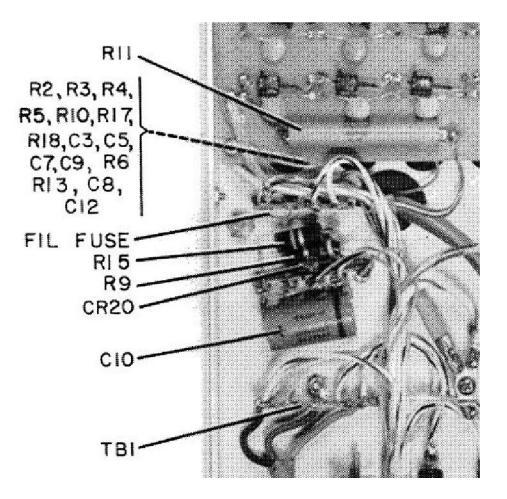
- 5. Remove only the bottom cover from the unit.
- 6. Locate the five-terminal terminal strip where R9, R15, C10 and CR-20 are located. Refer to figure 6-1 in the 30L-1 Instruction Book.

- 7. Carefully clip the leads of the existing R15 10K Ω 2 watt resistor leaving as much lead as you need for your preferred new resistor installation.
- 8. Prepare the new R15 5 watt resistor by forming the leads attaching them to the same terminals where the 2 watt carbon resistor was removed. Install the resistor in the same location close to the chassis and so that the value is visible when the cover is removed.
- 9. Replace the bottom cover.
- 10. Reversing the above removal process, replace the cabinet and feet on the unit chassis.
- 11. Reconnect the a-c cord and other external leads as required.
- 12. Check unit for 110 to 120 mA idle current when keyed but no drive. Be sure and terminate the amplifier with a 50 Ohm load while running this check. Then, check the resting bias voltage at the rear ANT RELAY RCA jack. It should be approximately negative 165 Vdc (Amplifier unkeyed).
